942-7191376-01

Kraftfahrt-Bundesamt
24932 Flensburg, Germany

Vehicles with R1234yf as refrigerant

Technical Report
Investigations into the possible flammability of refrigerant R1234yf
in motor vehicles

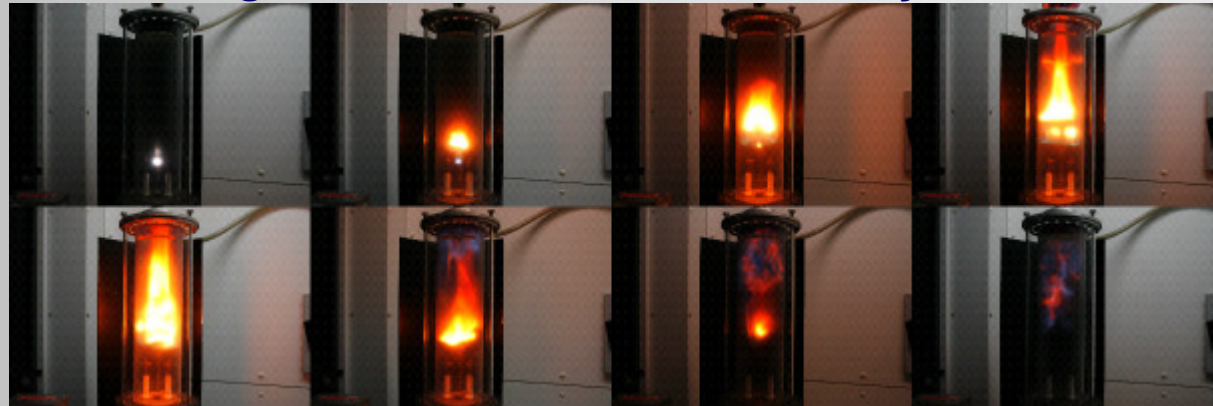
Ignition at 13.0 mole-% R1234yf

Pure R-1234yf can also burn with a bright yellow flame. The colour of the flame depends mainly on the concentration of the refrigerant.

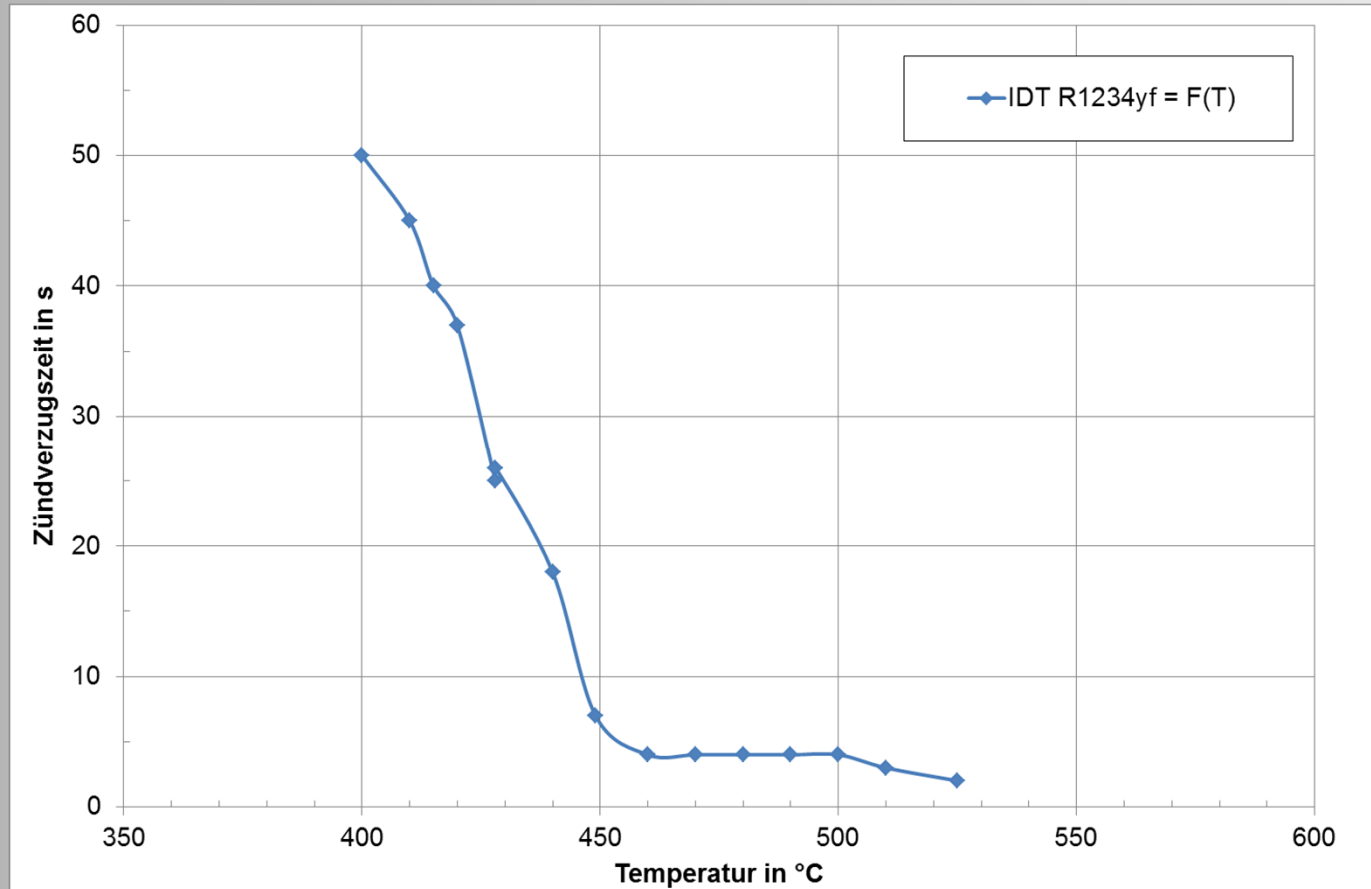
- Results $IDT = f(T)$ -

As surface temperature rises, the ignition delay time reduces. Taking account of the triggering time of 2s for 20ml of R-1234yf, at temperatures > 525 °C immediate ignition is to be expected.

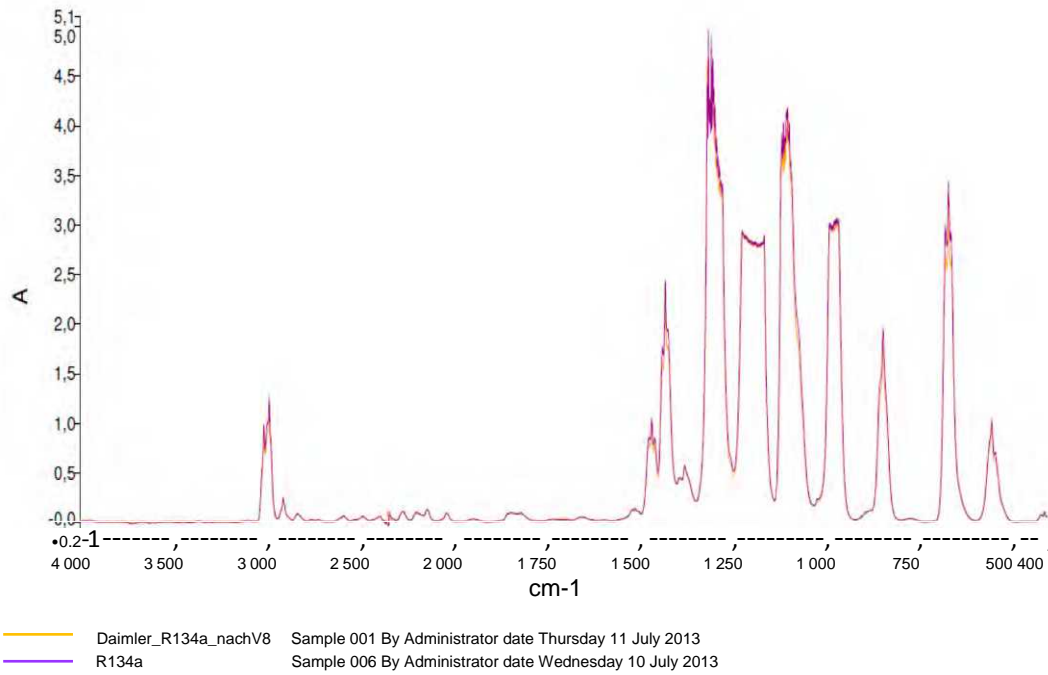
Figure 6: FT-IR spectrum of 1,1,1,2-tetrafluoroethane (R134a) ; gas sample from the service interface of the Daimler B-Class air conditioning system after a leak test using R134a and from the automatic air conditioning service station, each taken in a 20 mm gas cell

Ignition of R1234yf was observed in a leak test with a car, so the air conditioning system was filled with R134a for a final test. After the leak test, once again a gas sample was taken via the car's air conditioning service interface and compared to the absorption spectrum of pure R134a. The result is illustrated in Figure 6. No deviations were visible, so it is assumed that the car's air conditioning system was filled cleanly with R134a without any residue of R1234yf. In this case, again, under these conditions, no oil fractions were included in the sampling.
