942-7191376-01

Kraftfahrt-Bundesamt
24932 Flensburg, Germany

Vehicles with R1234yf as refrigerant

Technical Report
Investigations into the possible flammability of refrigerant R1234yf
in motor vehicles

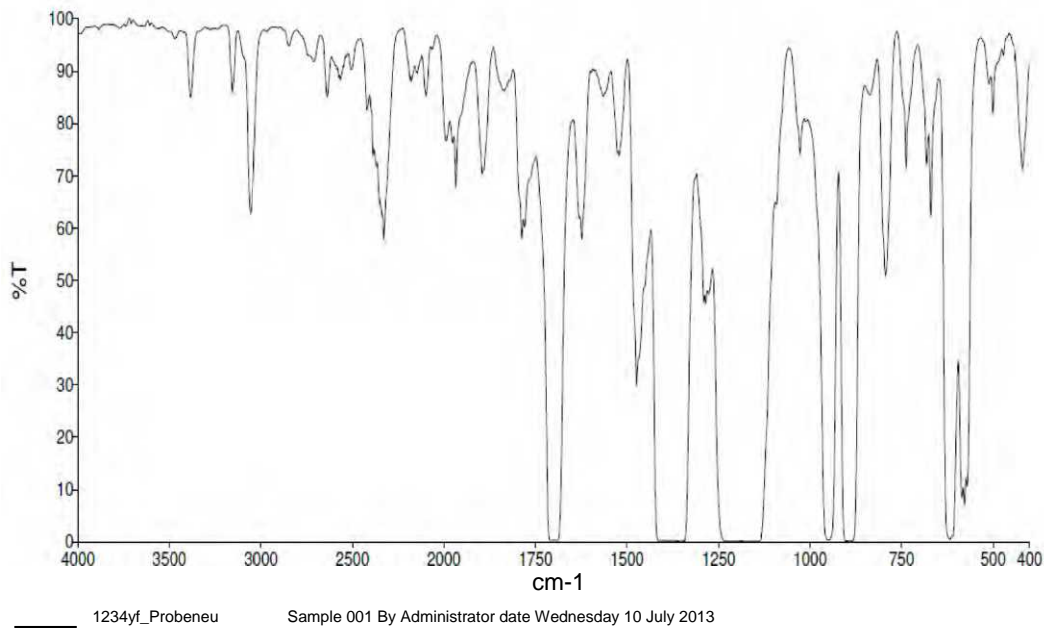
Figure 2 shows the FT-IR spectrum of R1234yf recorded, shortly before the automatic air conditioning service station gas cylinder was refilled, in a 20 mm gas cell using a Perkin Elmer Spectrum Two IR Spectrometer. It was not possible definitively to dilute the gas extracted from the gas cylinder, so the refrigerant was analysed pure. This resulted in overloading of the signals in various wave number ranges. Nevertheless, the characteristic peaks of R1234yf were clearly identifiable. The peaks on the baseline which were not very distinct in the reference spectrum were much more pronounced in the sample spectrum. There was no indication of peaks attributable to possible contamination.

Figure 2: FT-IR spectrum of 2,3,3,3-tetrafluoroprop-1-ene (R1234yf); gas sample from the gas cylinder for refilling the service station, taken in a 20 mm gas cell

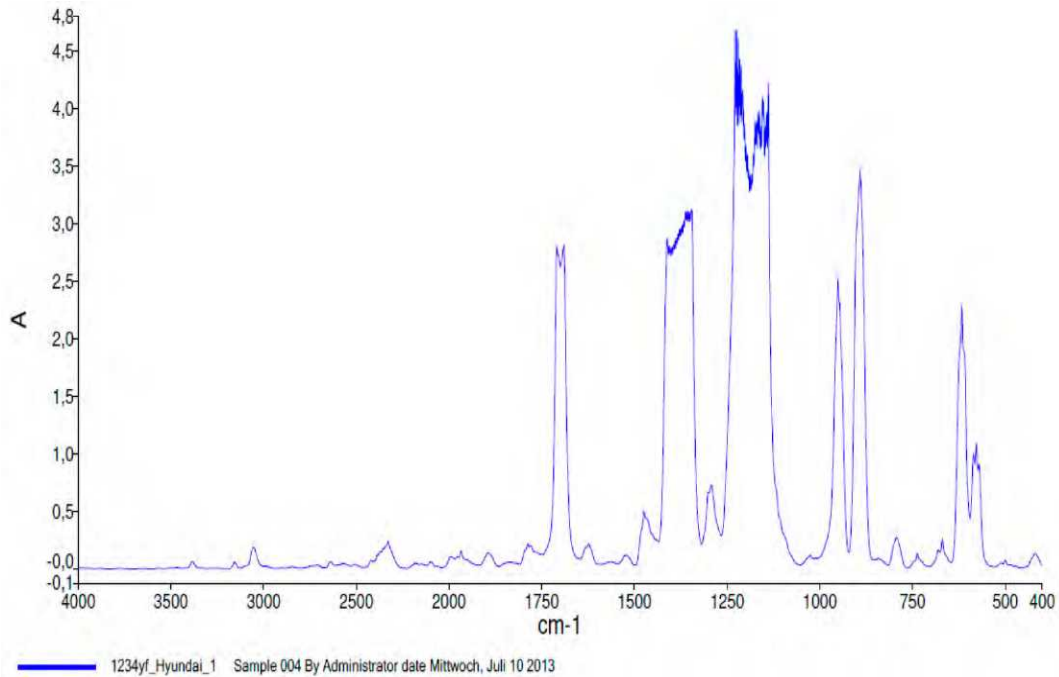
Retrospectively, it should be verified that in the previous leak tests, too, the car air conditioning systems were properly filled with R1234yf. To this end, for example, after testing the Hyundai i30 and the Opel Mokka, gas samples from the service interfaces of the air conditioning systems were fed into the gas cell and subsequently analysed. The absorption spectra are illustrated in Figures 3 and 4. In both cases, it is clear that the air conditioning systems were filled with the R1234yf refrigerant. Under these conditions, no oil fractions were included in the sampling.

Figure 3: FT-IR spectrum of 2,3,3,3-tetrafluoroprop-1-ene (R1234yf); gas sample from the service interface of the Hyundai i30's air conditioning system after a leak test, taken in a 20 mm gas cell.

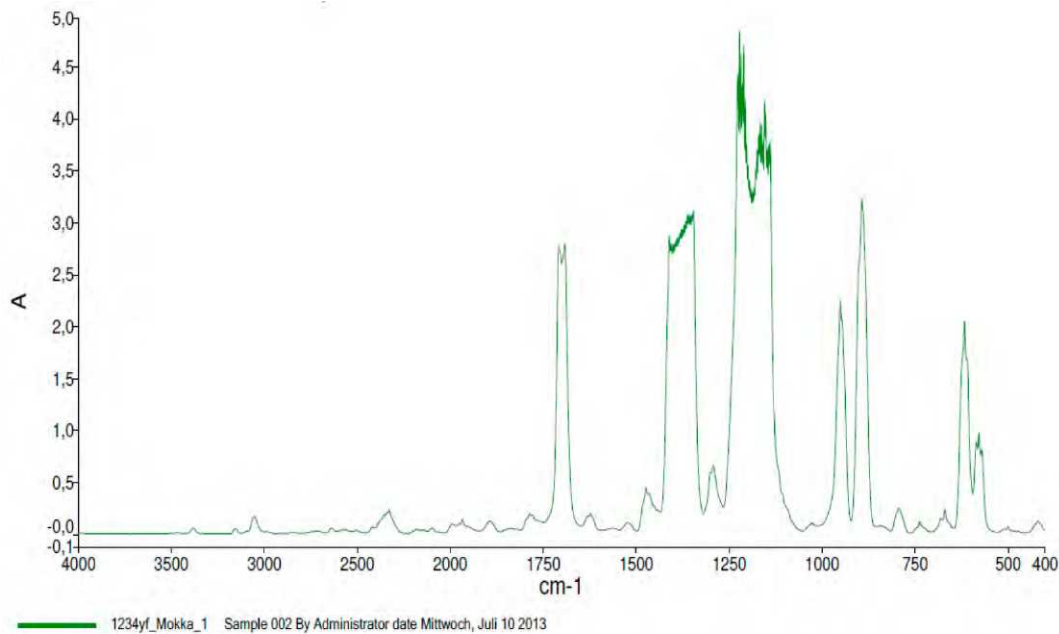
Figure 4: FT-IR spectrum of 2,3,3,3-tetrafluoroprop-1-ene (R1234yf); gas sample from the service interface of the Opel Mokka's air conditioning system after a leak test, taken in a 20 mm gas cell.

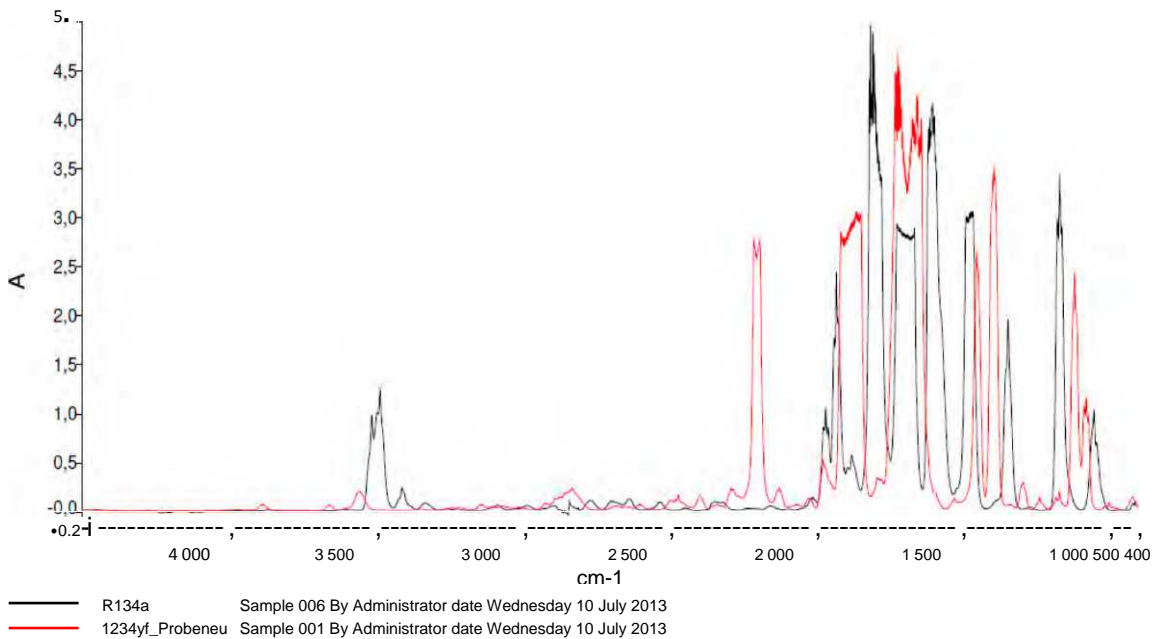
Figure 5: FT-IR spectrum of 2,3,3,3-tetrafluoroprop-1-ene and 1,1,1,2-tetrafluoroethane (R134a) respectively, each taken in a 20 mm gas cell

Distinct differences emerge between the two spectra. The biggest differences are the individual peak for R134a at a wave number of $3\,000\text{ cm}^{-1}$ and the isolated peak for R1234yf at a wave number of $1\,700\text{ cm}^{-1}$.

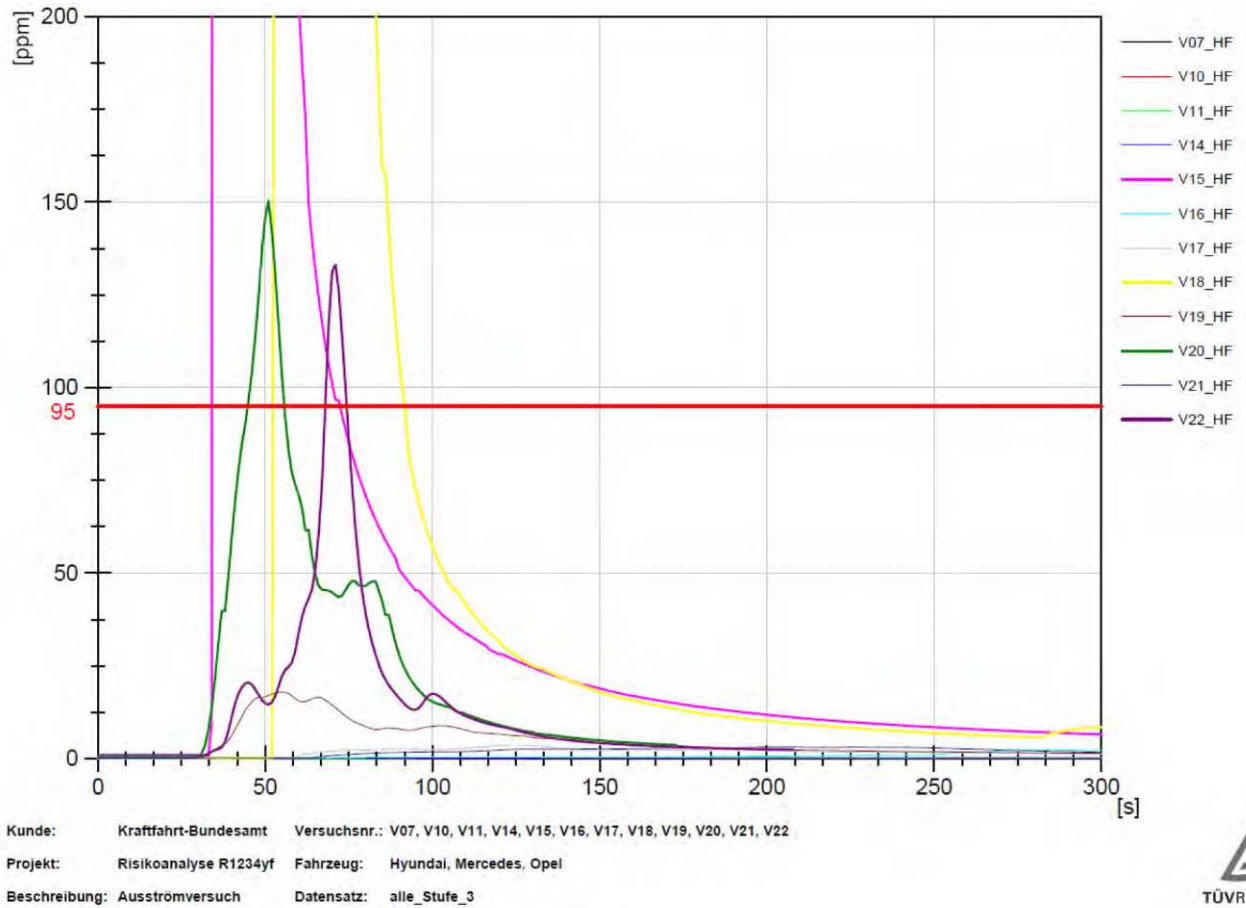
Figure 1: First measurement sheet provided by KBA

- Concentrations < 0.5 ppm HF, as measured in Tests 1–14, do not raise any expectation of damage to health.
- In Tests 16, 17, 19 and 21, HF concentrations in the range of 2.4 to 18 ppm were obtained, for which the occurrence of slight, reversible irritation of the respiratory passages, skin and eyes — i.e. not associated with any permanent damage to tissue — is probable.
- In Tests 20 and 22, HF concentrations were obtained from which severe, irreversible damage [severe irritation or chemical burns to the respiratory tract with possible tissue destruction (formation of necroses) and restriction of lung function, chemical burns to skin and eyes] is probable.
- At concentrations as found in Tests 15 and 18, the observed range of mortality in tests on animals is 50–100 %. In this respect, acute danger to life is to be assumed for persons suffering this level of exposure.

Client:	KBA	Test nos.:	V07, V10, V11, V14, V15, V16, V17, V18, V19, V20, V21, V22
Project:	Risikoanalyse R1234yf	Vehicle:	Hyundai, Mercedes, Opel
Description:	Discharge test	Data set:	all_stage_3

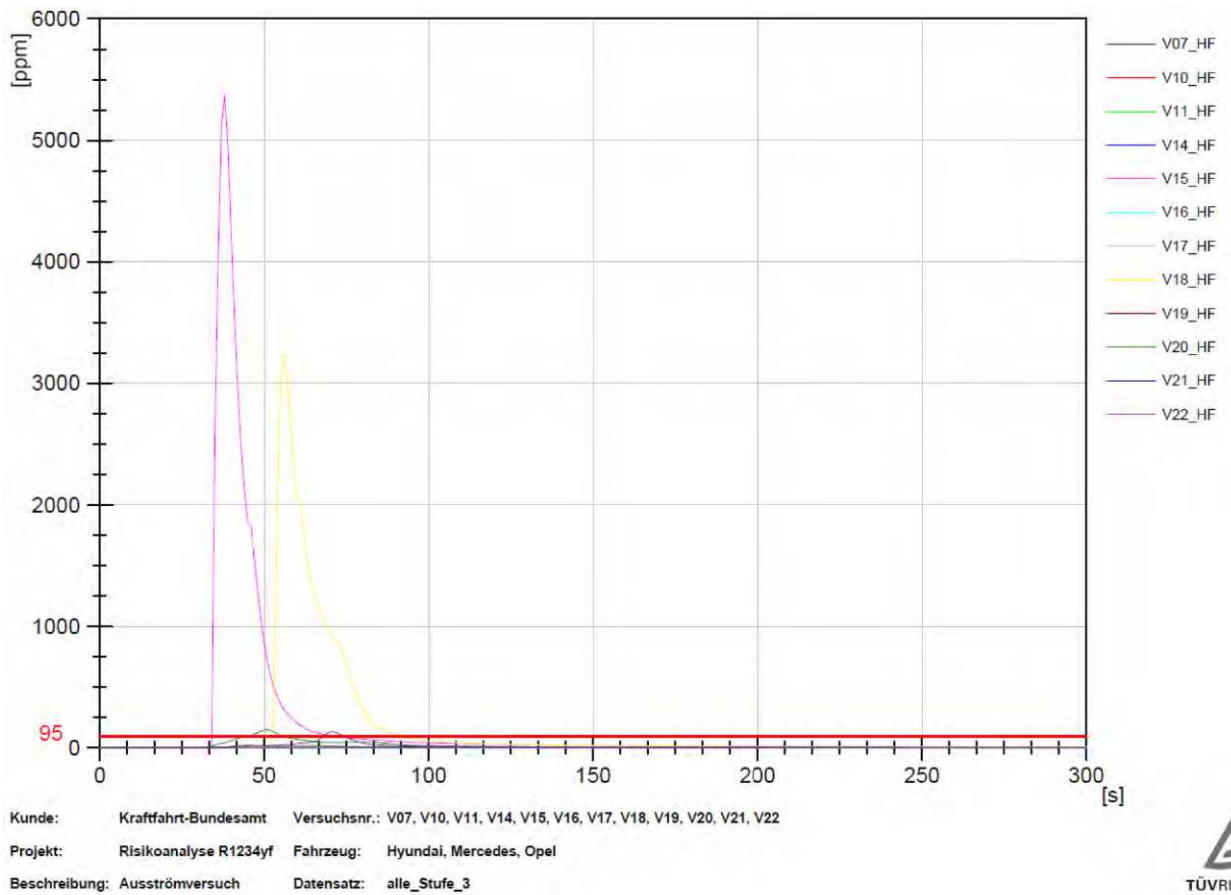
Figure 2: Second measurement sheet provided by KBA

Client:	KBA	Test nos.:	V07, V10, V11, V14, V15, V16, V17, V18, V19, V20, V21, V22
Project:	Risk analysis R1234yf	Vehicle:	Hyundai, Mercedes, Opel
Description:	Discharge test	Data set:	all_stage_3

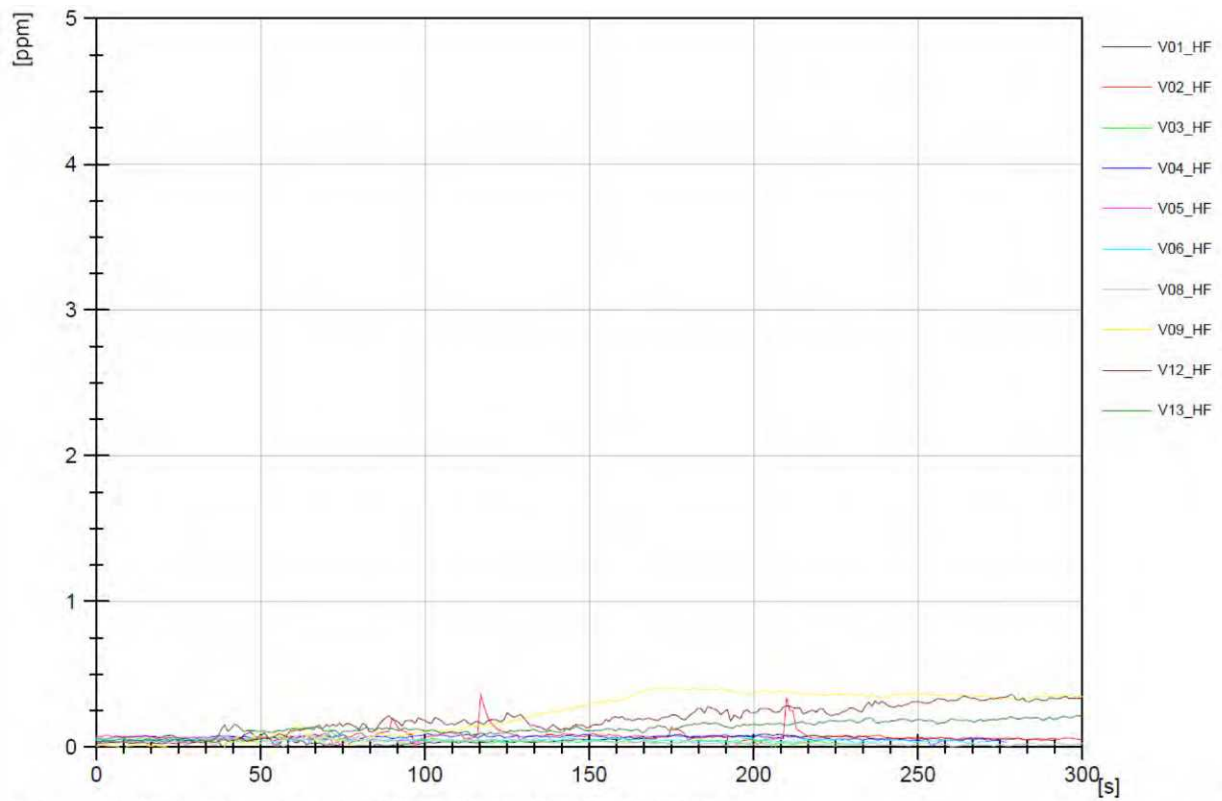
Figure 3: Third measurement sheet provided by KBA

Kunde: Kraftfahrt-Bundesamt Versuchsnr.: V01, V02, V03, V04, V05, V06, V08, V09, V12, V13
 Projekt: Risikoanalyse R1234yf Fahrzeug: Hyundai, Mercedes, Opel, Subaru
 Beschreibung: Ausströmversuch Datensatz: alle_Stufe_1+2
