WFD AND HYDROMORPHOLOGICAL PRESSURES

TECHNICAL REPORT

- CASE STUDIES -

Potentially relevant to the improvement of ecological status/ potential by restoration/ mitigation measures

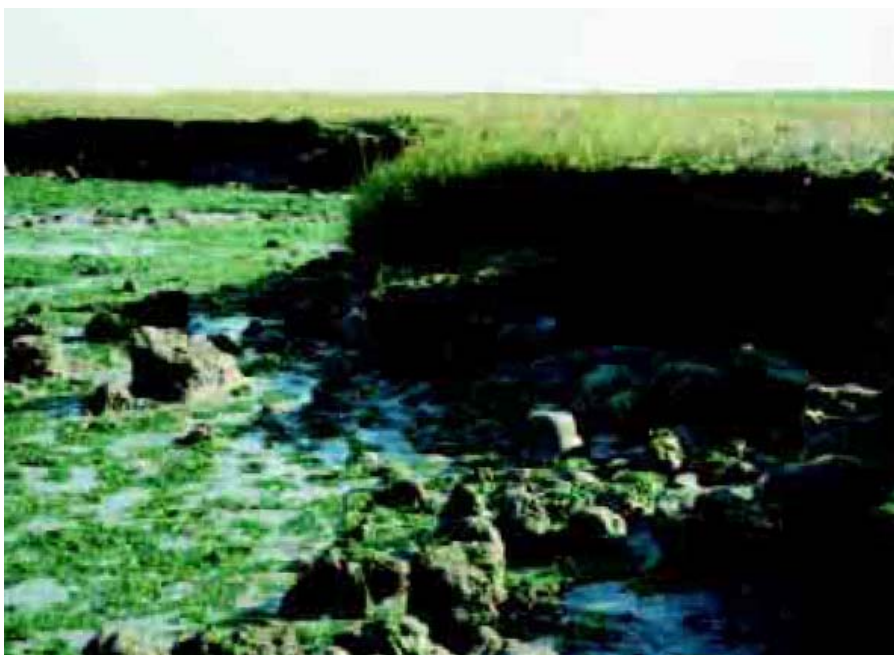
Figure 1: Picture of an eroding salt marsh.

- As a consequence of the construction of a storm surge barrier in the mouth of the Oosterschelde and the construction of dams in the eastern and northern landward branches of the estuary, the tidal range in the estuary diminished and silt concentrations have decreased. This resulted in a reduction of the accretion of the salt marshes, while erosion continued. The natural dynamical cycle of accretion and erosion changed into a continuous erosion process.
- Due to the construction of the landward dams 1000 ha of salt marshes were lost (became part of freshwater systems with no connection to the estuary).
- The average loss of salt marsh surface area caused by the net erosion is approximately 3 ha/year on a remaining total surface of 500 ha.

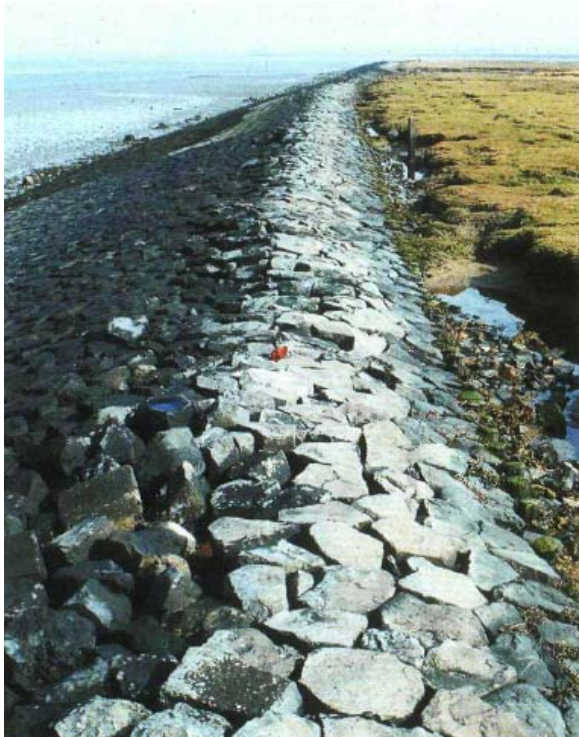
Figure 2: Picture of a marsh protection.

- Construction of a low dam of stones along the edge of salt marshes

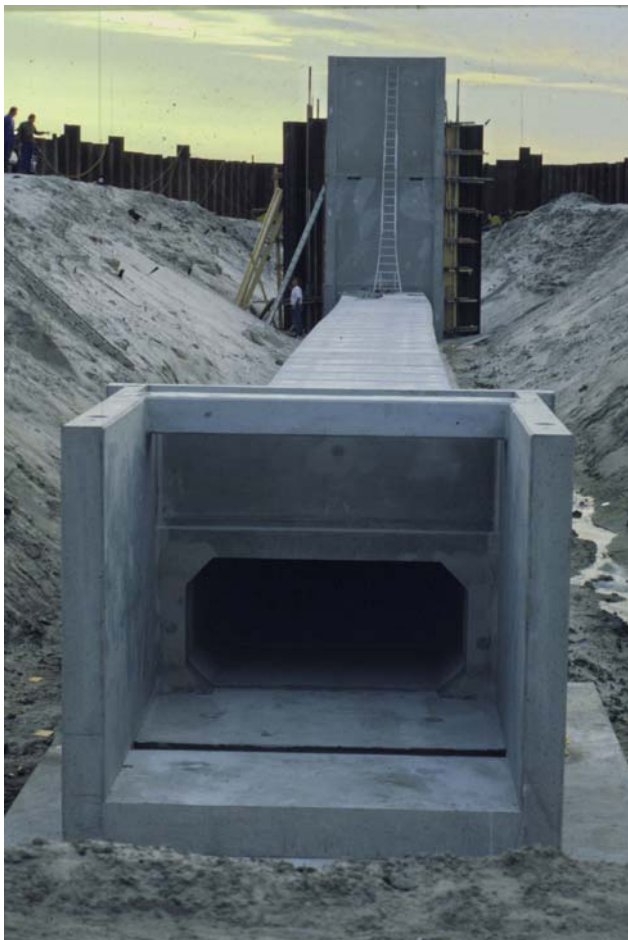
Figure 1: Culvert in the dyke between the Ems-Dollart.

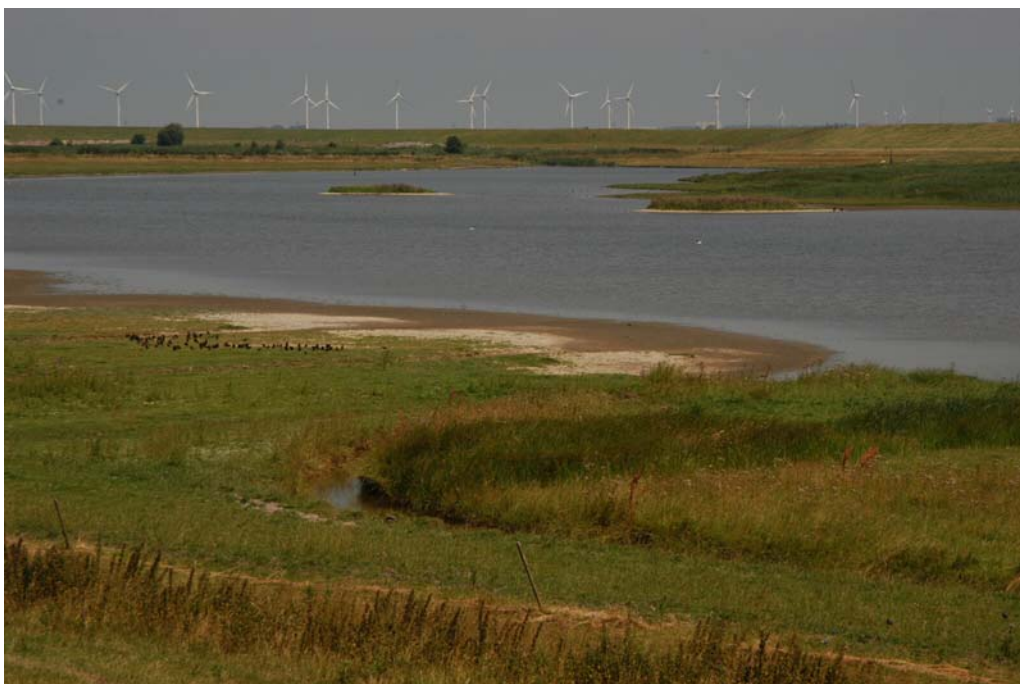
Figure 2: Restored tidal watercourse in the former polder Breebaart.

- Partial restoration of the former tidal watercourse

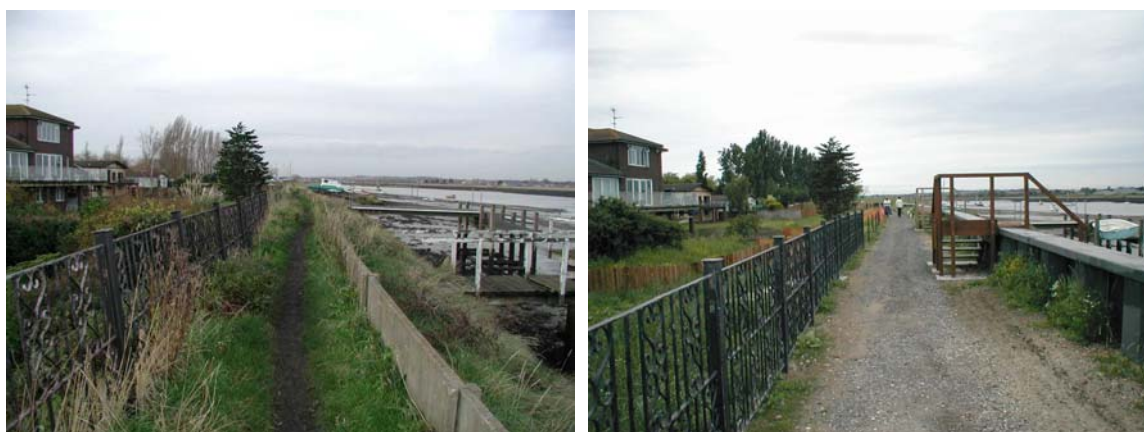
Figure 1: Defences which required improvement (left) and new defences at end of works (right).

- In the village of Hullbridge there were approximately 40 properties, a residential caravan park, and two sailing clubs which required improved flood defences. The area adjoins a site which has SSSI, cSAC, SPA and Ramsar environmental designations.
- The improvements to the tidal defences involved widening the whole of the embankment to give a minimum of 3 metre wide crest and an increase in level by approximately half a metre to provide a 1 in 50-year standard of protection.
- The flood defence works led to some loss of intertidal habitat, and would lead to future losses by failing to allow migration of habitats landwards as sea levels rise. Mitigation for the effect of these works was required.

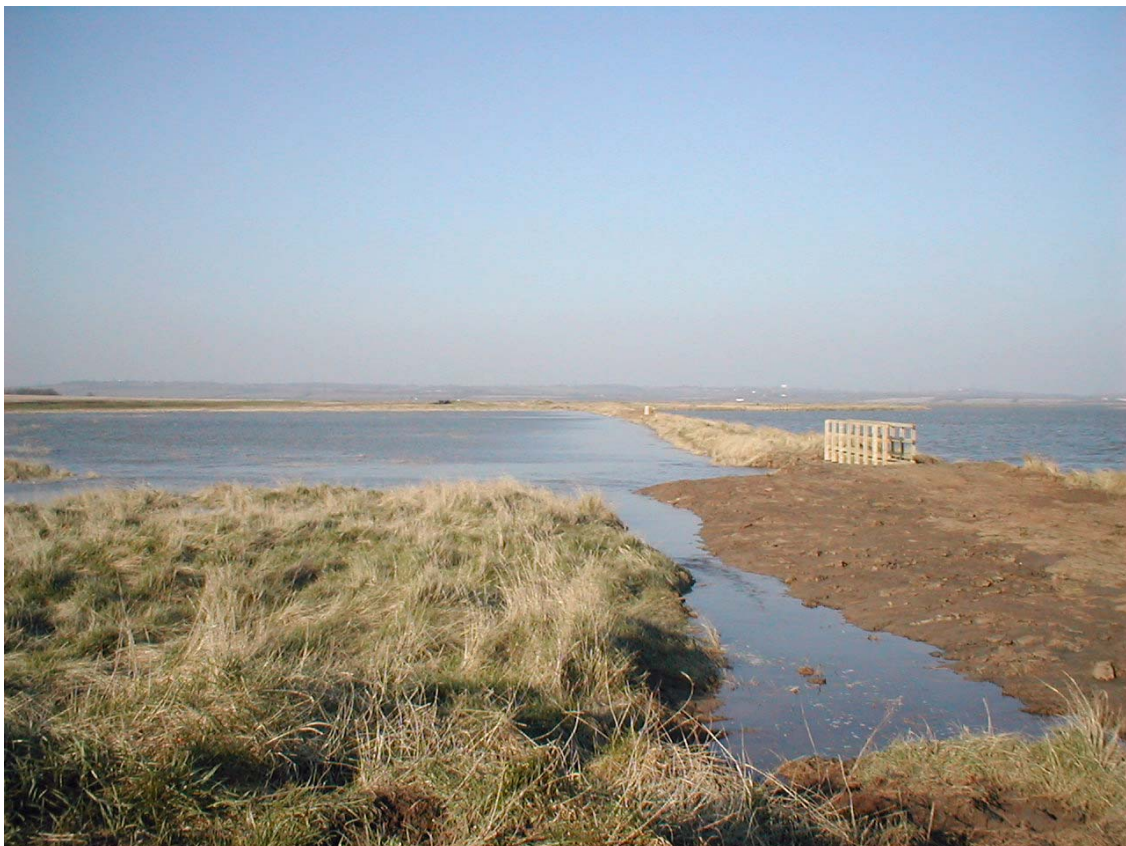
Figure 2: New area of intertidal habitat

- Creation of new intertidal habitats and ensuring no longer term deterioration in the extent of existing saltmarsh. The retreat area now has a fuller range of saltmarsh communities.
- Provision of breeding area for fish species.

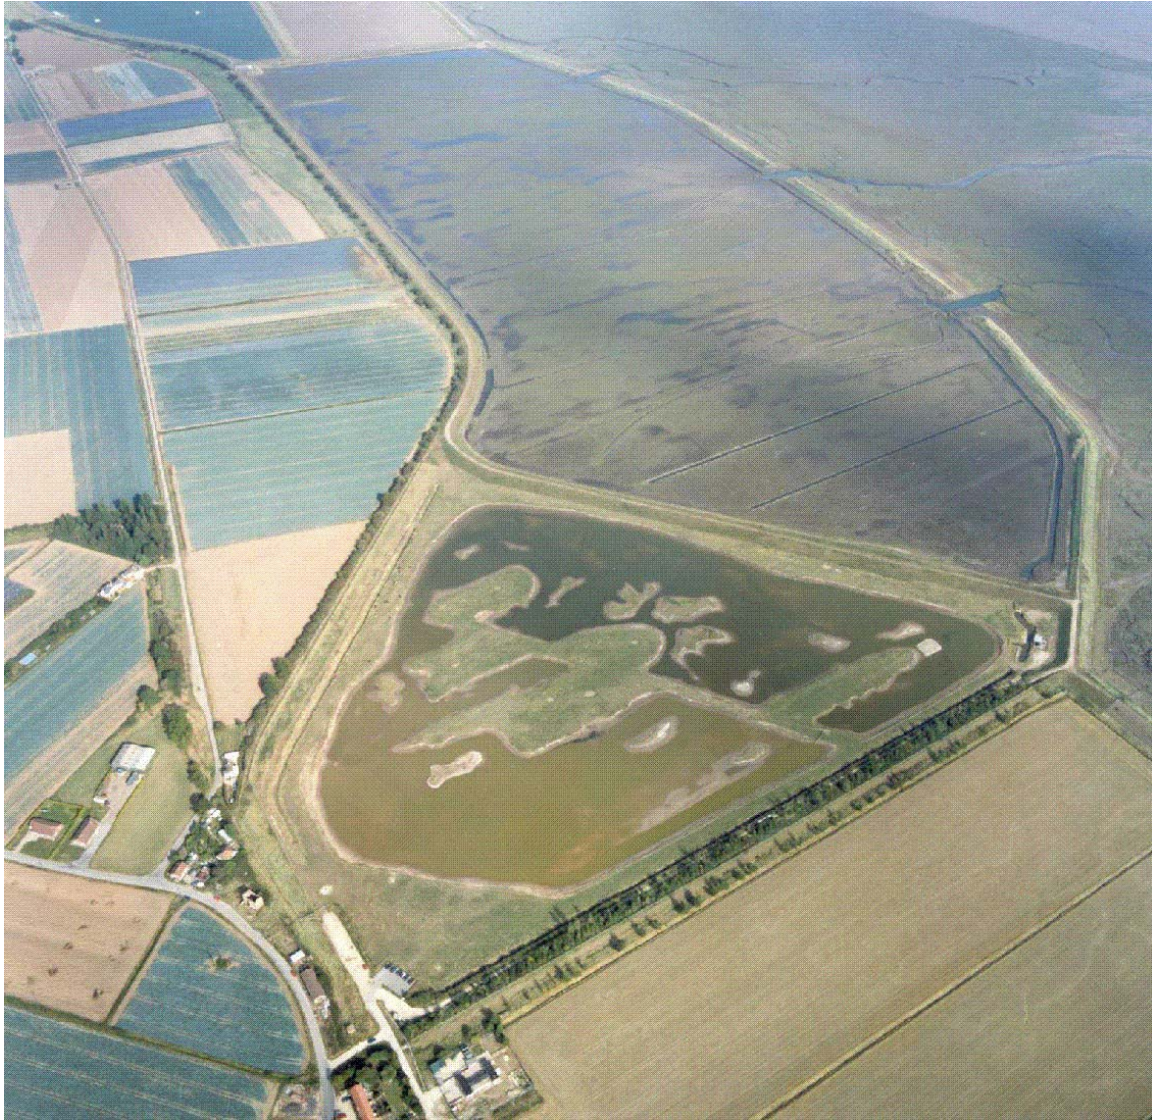
Figure 2: The completed realignment site.

- The site has reverted to an intertidal area which is more natural and more sustainable. The transition zone has been widened and the quality of habitat has improved as the site accretes to a more natural land level. After a period of quick initial changes on the outer mudflats, tidal creeks and elevation is now more stable.

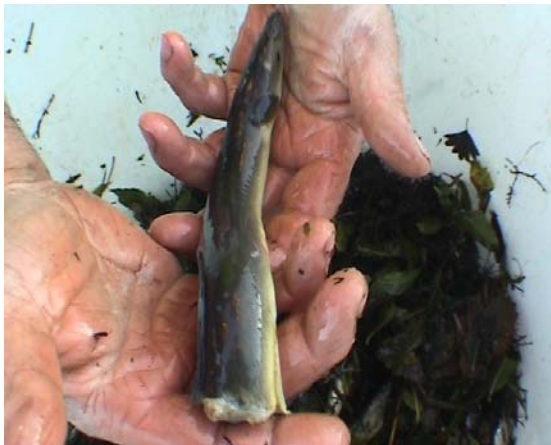
Figure 1: Damaged eel that migrated through a conventional pumping station with a propeller pump.

- For fishes, pumping stations represent migration barriers that disturb the natural connection between adjacent water bodies. Once fishes find themselves in a polder, they are unable to migrate downstream without the passage of at least one pumping station. The risk that fish passage through these pumps results in severe or lethal damage is high (cf. Figure 1).

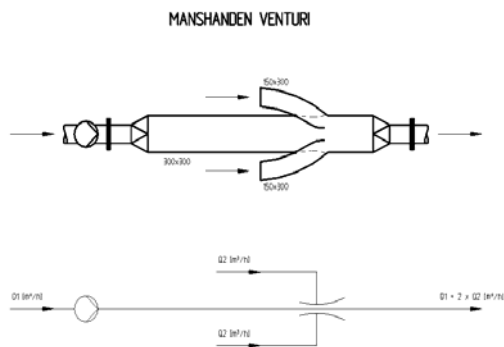
Figure 2: The Venturi principe.

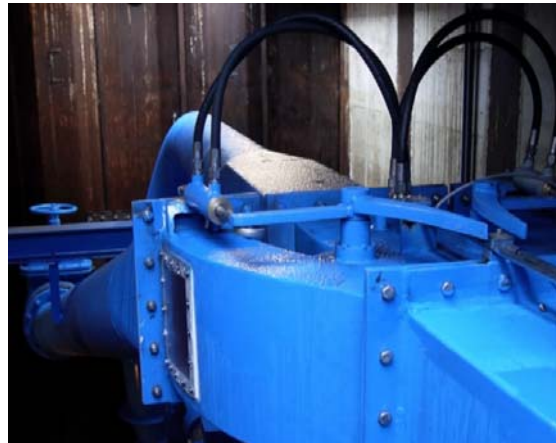
Figure 3: The Venturi at Waterboard Hunze & Aa's.

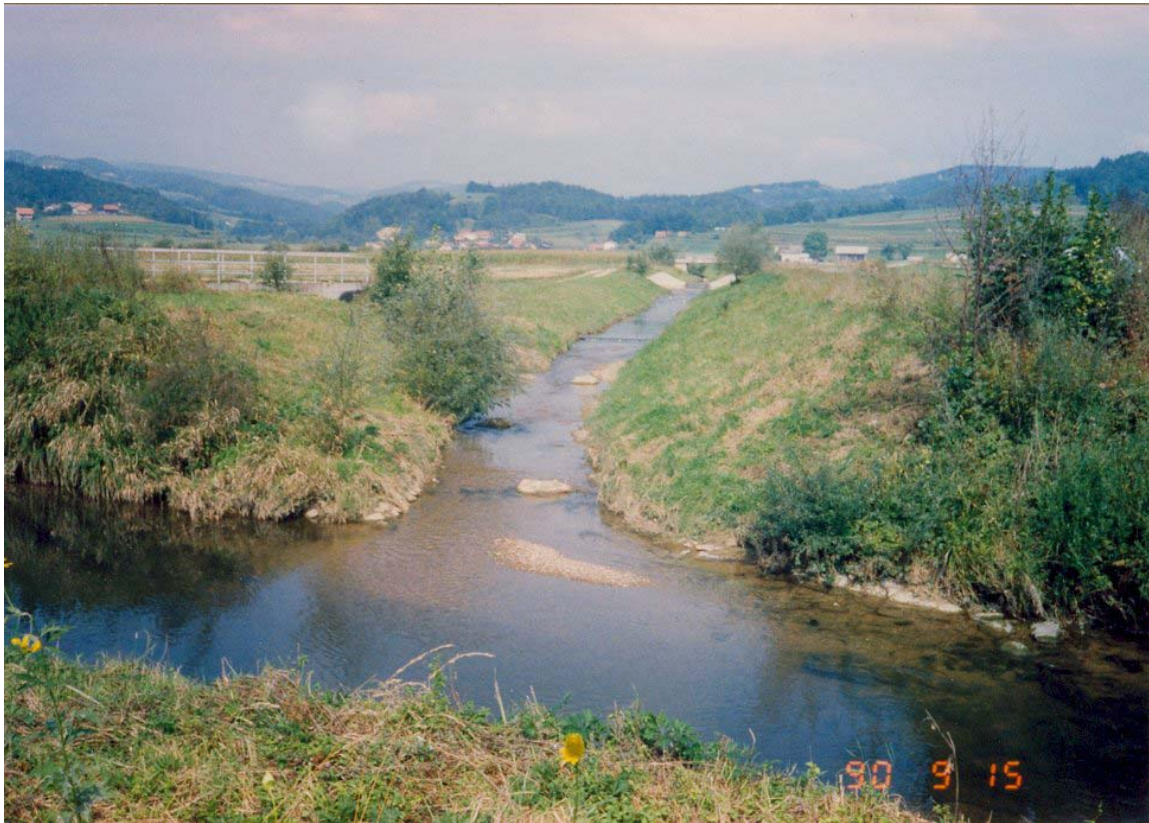
Figure 1: Jeseniscica River at Novo mesto, river course straightening in late 80', situation in 1990.

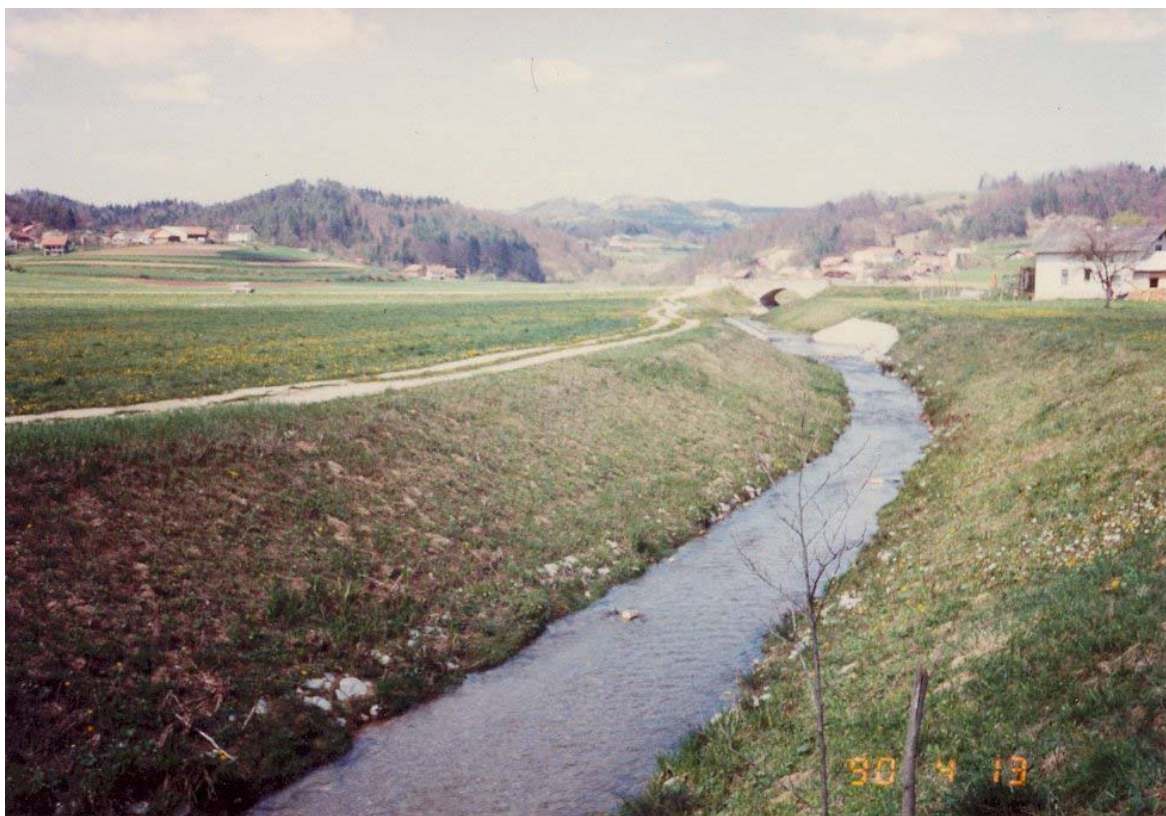
Figure 2: Jeseniscica River at Novo mesto, river course straightening in late 80', situation in 1990.

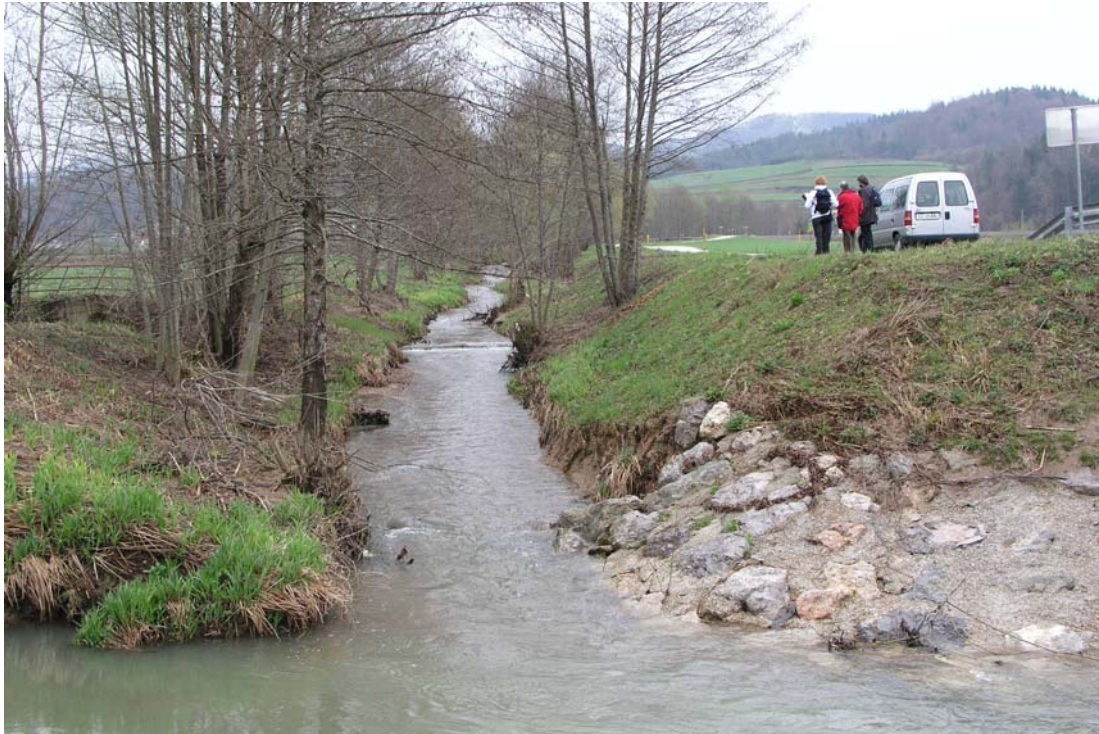
Figure 3: Jeseniscica River at Novo mesto, situation in 2006.

- Installation of deflectors to initiate the process of bank erosion and consequently creation of river bends in the length of 1.5 km
- Alteration of the cross sectional steps from concrete to wooden structures, designed to initiate downstream pools
- Creation of temporary fish hideouts in river banks
- Planting of riparian vegetation

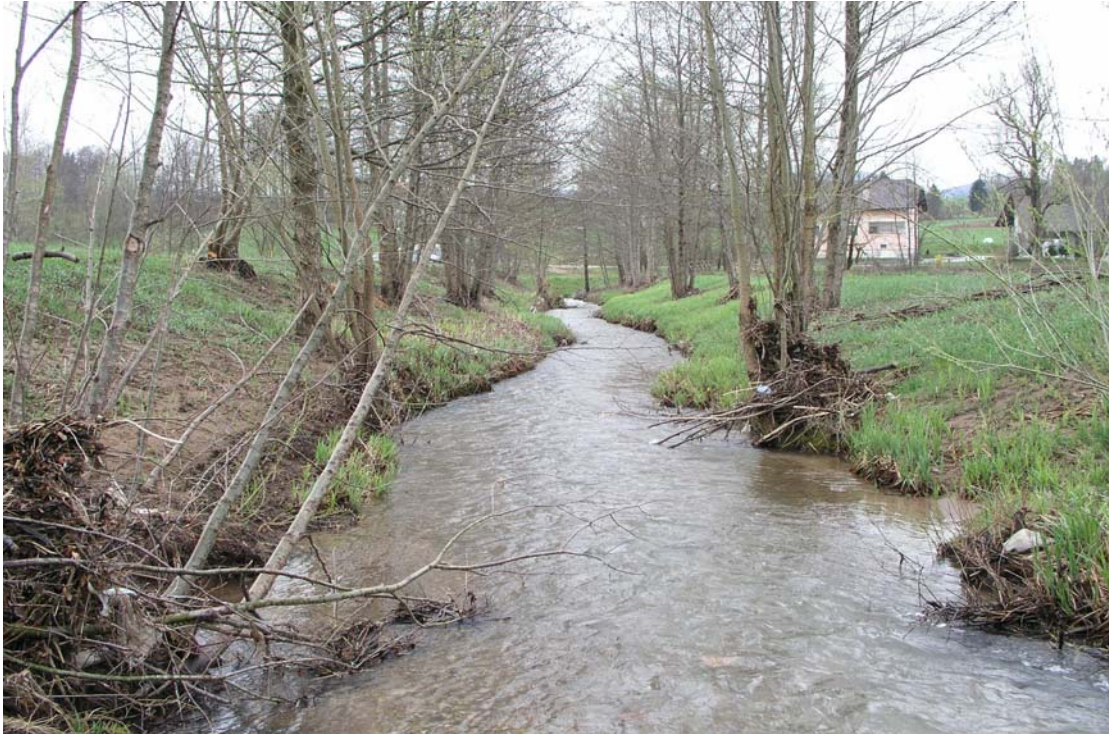
Figure 4: Jeseniscica River at Novo mesto, situation in 2006.

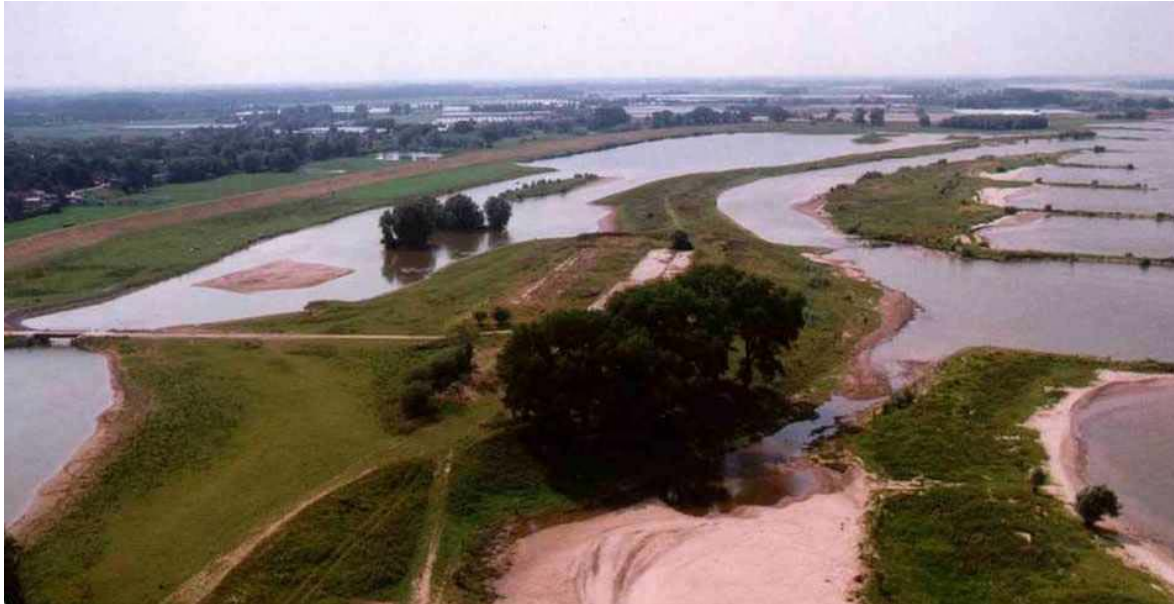
Figure 1: River Rhine at Gameren after hydromorphological improvement (photo Jaap de Vlas, July 2001).

- On the right the main channel with groynes and rehabilitated riparian zones.
- On the left winter embankments.
- In the middle the floodplain (128 ha) with three channels: on the left a permanent channel of 2 km, at the top a 1 km channel flowing approx. 265 days/year and below a partly silted up channel flowing approx. 100 days/year.

- Room for riverine processes resulted in a diversity in flow conditions and inundations frequencies, erosion and sedimentation. This created specific habitats, such as dynamic shallow water, sandy banks and soft wood forest, and a more natural gradient between water and land.

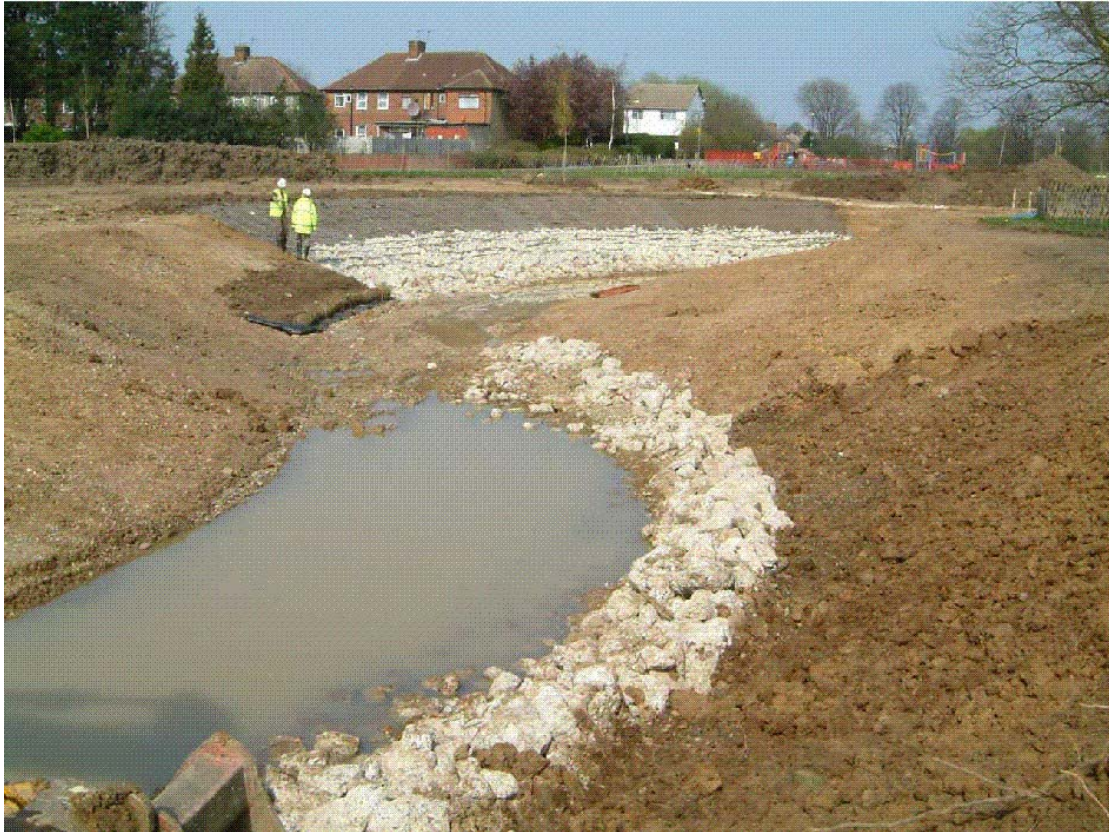
Figure 1: Status during construction.

- Artificial concrete banks were removed.
- A two stage channel was designed to accommodate a range of flows.
- The meandering planform of the river was restored. However due to the close proximity of residential areas the degree of channel adjustment had to be constrained through the channel design. Two types of revetment were used; type A on the apex of the meanders was designed to withstand higher flow velocities; and type B formed a transition between type A and the natural bank.
- Further revetment was required where the old concrete channel joined the new channel in order to reduce erosion where the water flows from a hard surface to the natural bank.
- Creation of backwater habitat
- Landscaping and planting of riparian vegetation, one major landscape feature that was created was a bund, used to reduce the visual and noise impacts from the North Circular.

- Construction of a 75 m gabion wall to stabilise a section of the bank.
- Installation of a bridge to improve public access.

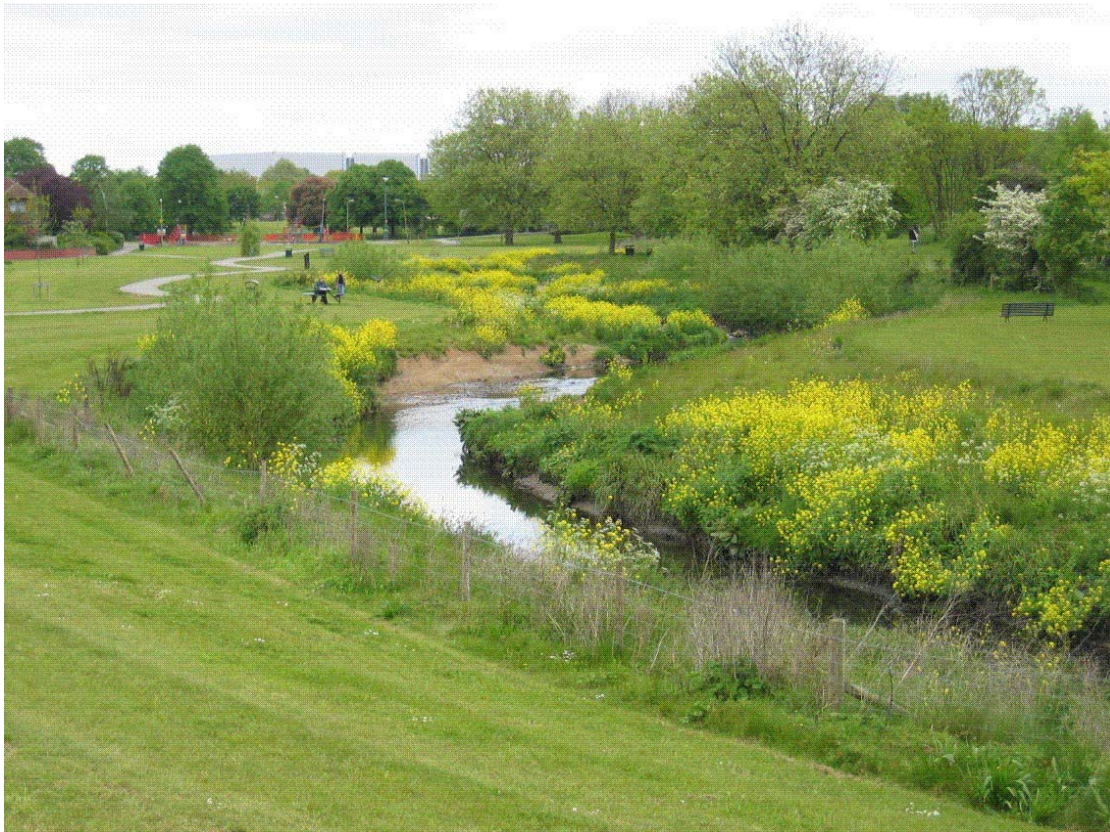
Figure 2: Site post construction.

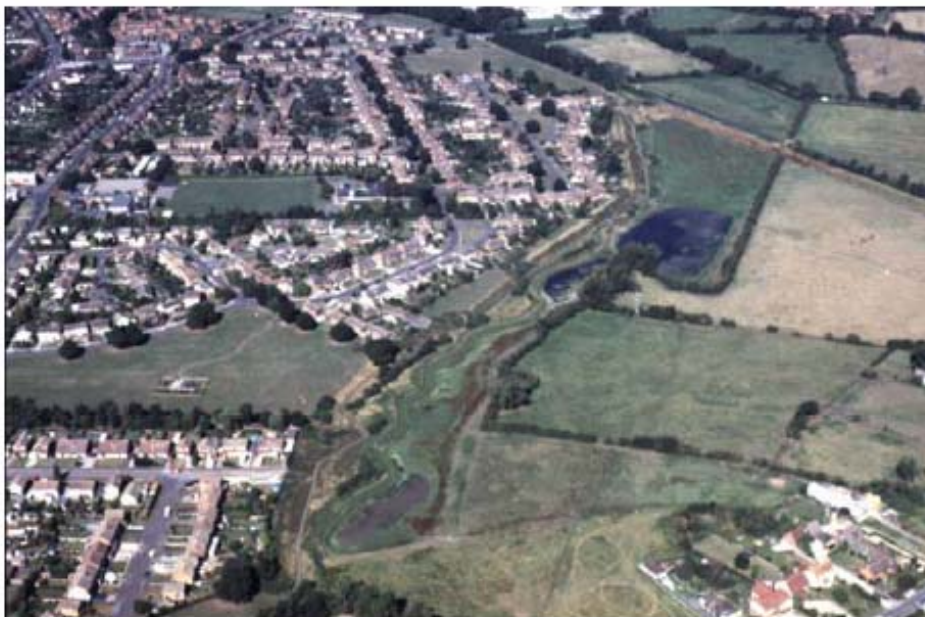
Figure 1: Area view of the brook and flood storage/overspill area.

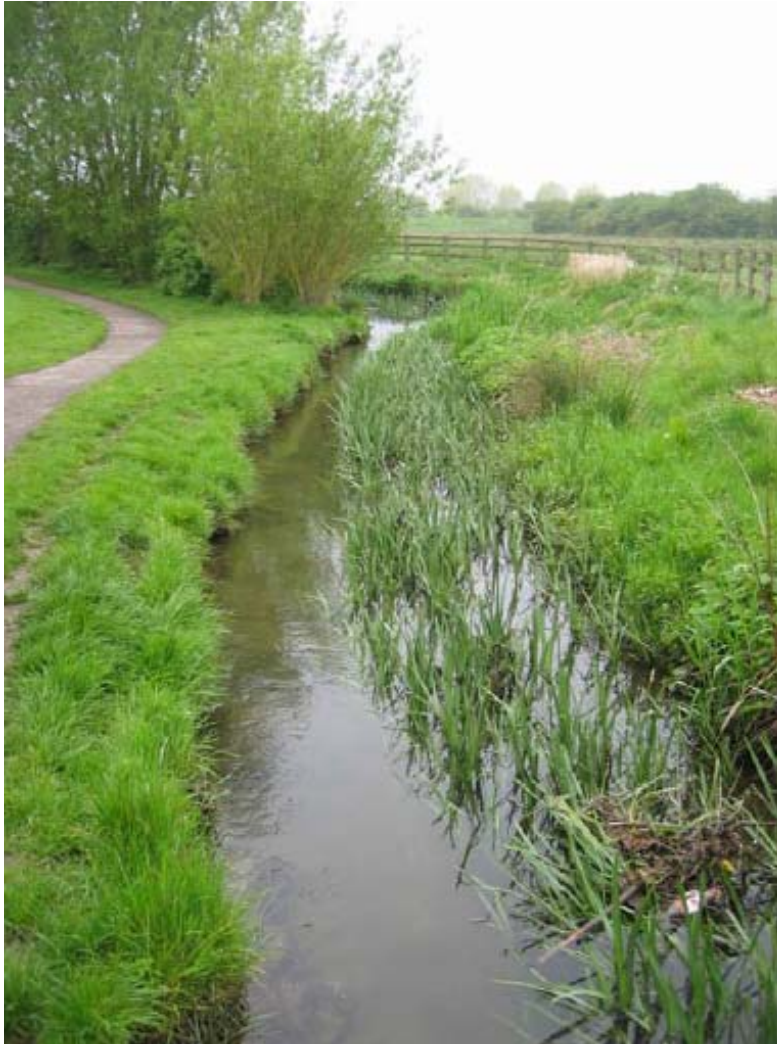
Figure 2: Narrowing as a result of silt deposition and marginal plant growth. The open channel section has a clean bed.

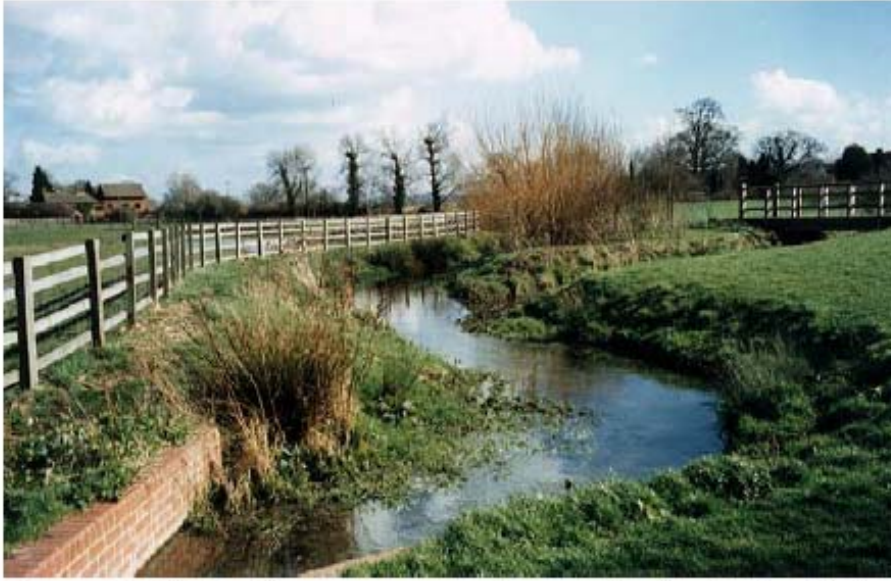
Figure 3: Vegetation is shaping the low flow channel, establishing in the deposited silty margins (four years after construction).

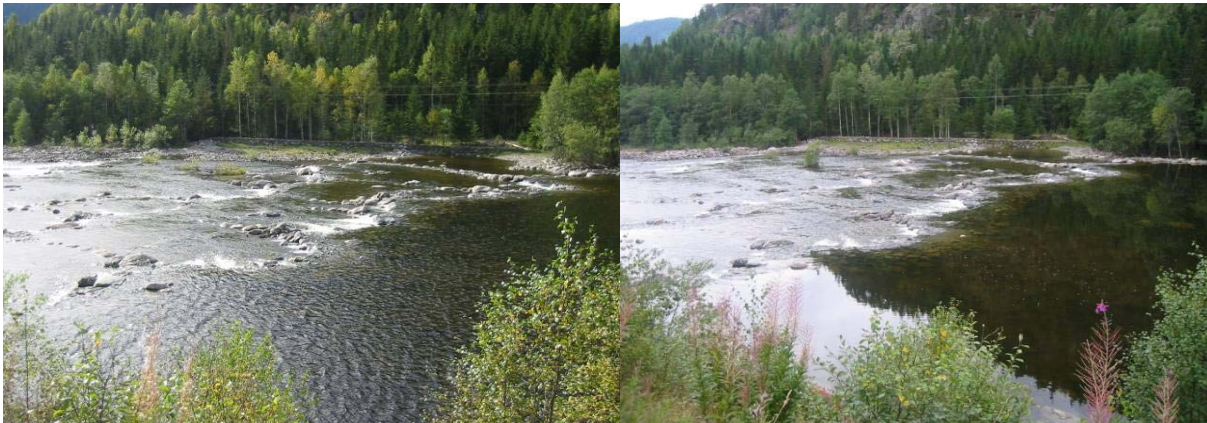
Figure 1: Section of river stretch at 3.5 m³/s (left) and 5.5 m³/s (right).
(Photo: NLB)

- Figure 1 shows the river section at 3.5 and 5.5 m³/s (slightly more than the minimum required flows of 3 and 5 m³/s).

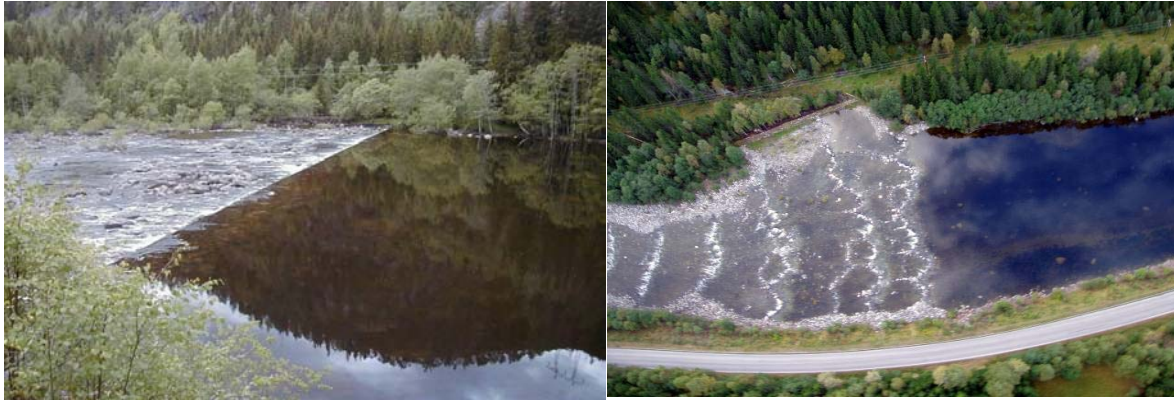
Figure 2: Section of part of the river before (left) and after new weir constructions (right - water flow from right to left) (Photo: NLB).

- Figures 2 and 3 show situations at two sites before and after the construction of new weirs.

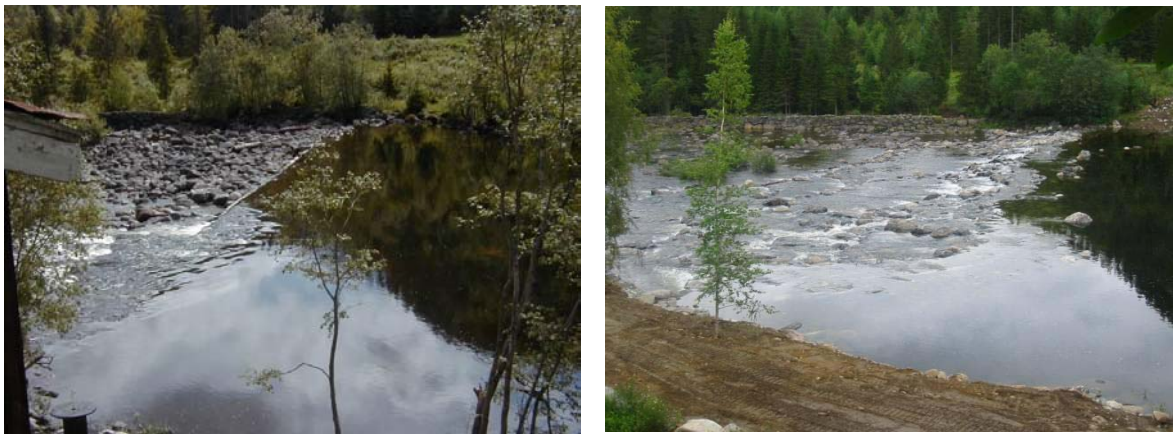
Figure 3: Man-made weir in part of the river before (left) and after weir reconstruction (right). Water flow from right to left. (Photo: NLB)

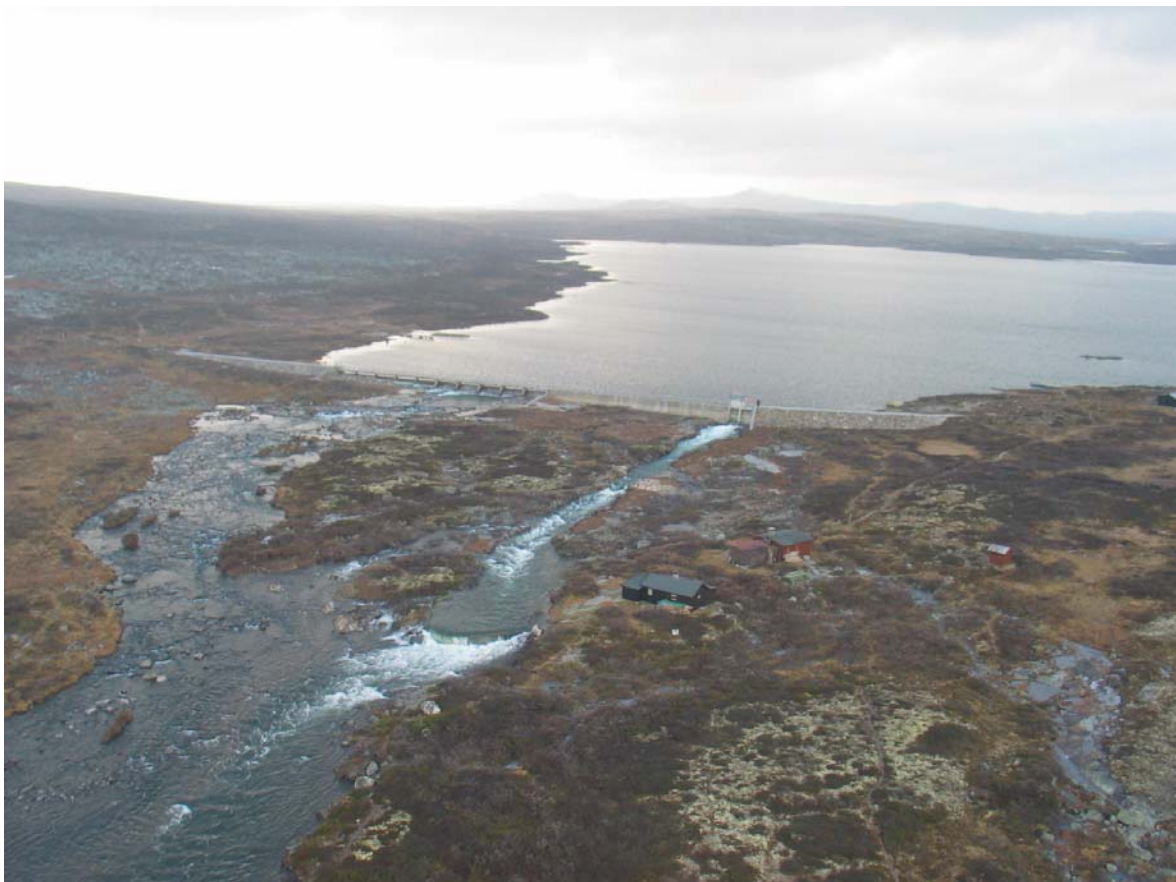
Figure 1: Downstream the dam of the Halnefjord reservoir.

- In the river channel to the left there is now a new requirement of $0.5 \text{ m}^3/\text{s}$ of minimum flow (photo shows situation at significantly higher discharge).
- A barrier has been constructed to ensure that fish do not swim up the channel to the right.
- The new fish pass is constructed at the top of the left-hand channel, cf. Figure 2.

- Minimum continuous flow requirement of $0.5 \text{ m}^3/\text{s}$ in the river downstream of the dam; and a requirement to keep the water level stable at the highest regulated level in the period between the spring flood and October 1st.
- New fish pass; to ensure that migratory fish can access spawning and breeding grounds. Also diversion barrier to prevent fish migrating up the wrong river channel (cf. Figure 1).
- Coconut matting erosion protection laid out in littoral zone to improve re-vegetation of barren zones and hinder erosion progressing towards cultural heritage sites (cf. Figure 3)

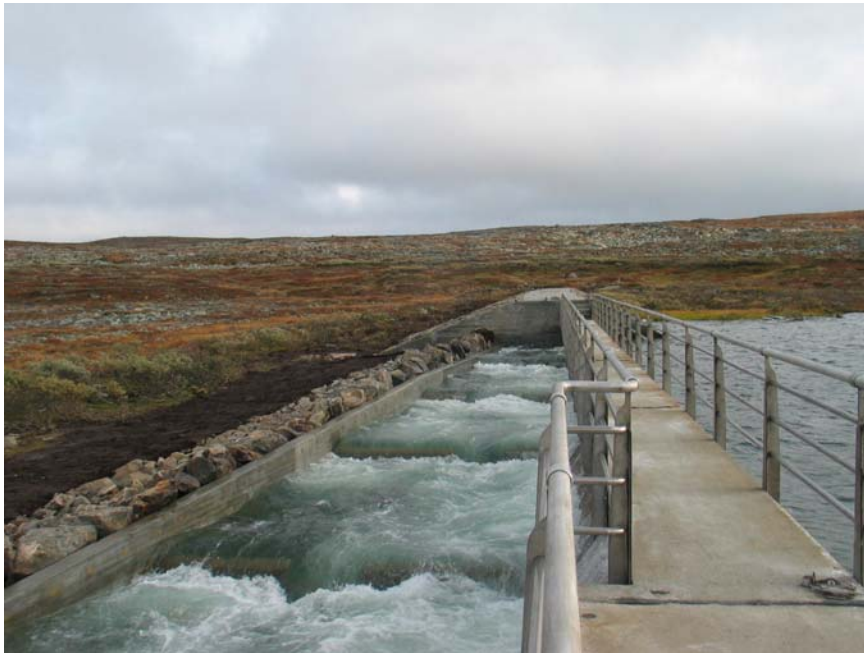
Figure 2: New fish pass at the dam of the Halnefjorden reservoir.

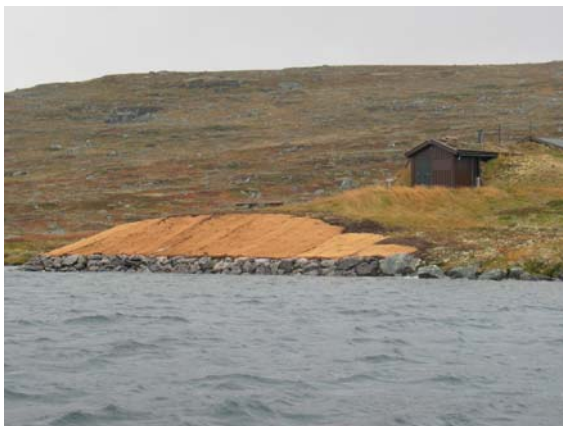
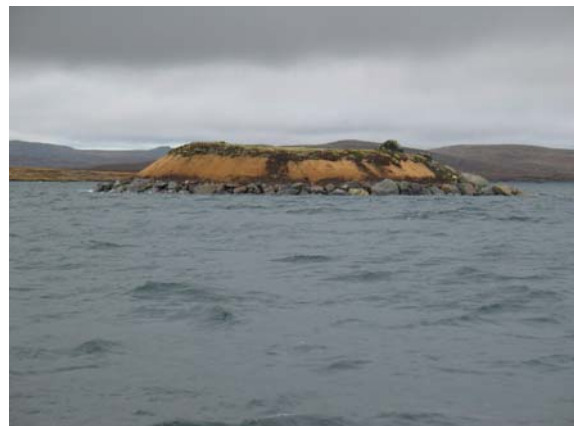
Figure 3: Coconut matting in the littoral zone of the Halnefjorden reservoir.

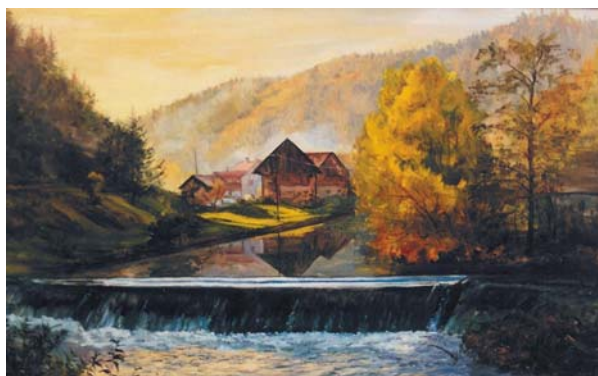
Figure 1: Dam on the Mirna River, view of an artist.

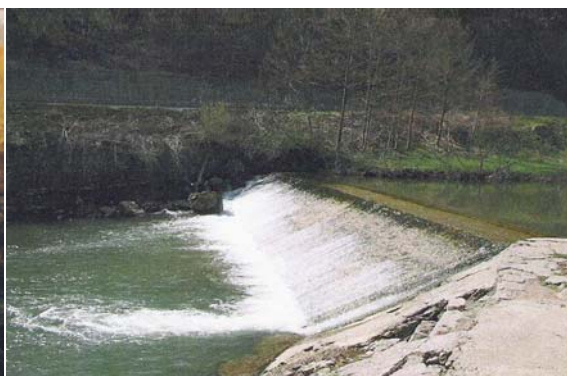
Figure 2: Dam on the Mirna River, situation in 2002.

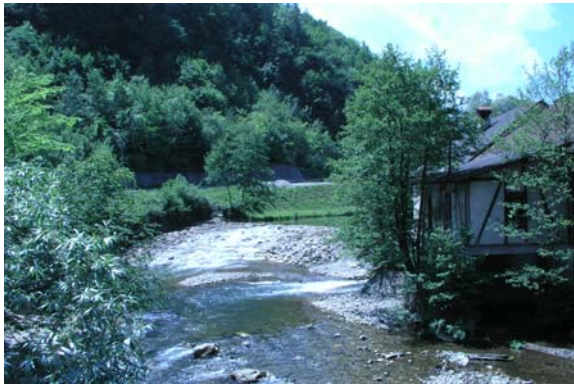
Figure 3: Rocky glide on the Mirna River, situation in 2006.

- Removing of obsolete dam
- Construction of rocky glide

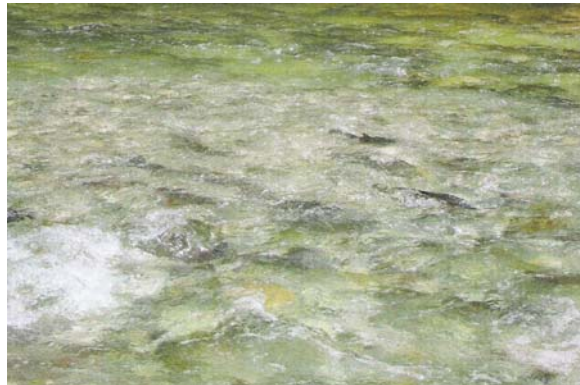
Figure 4: Nase carp passing the rocky glide on the Mirna River, 2006.

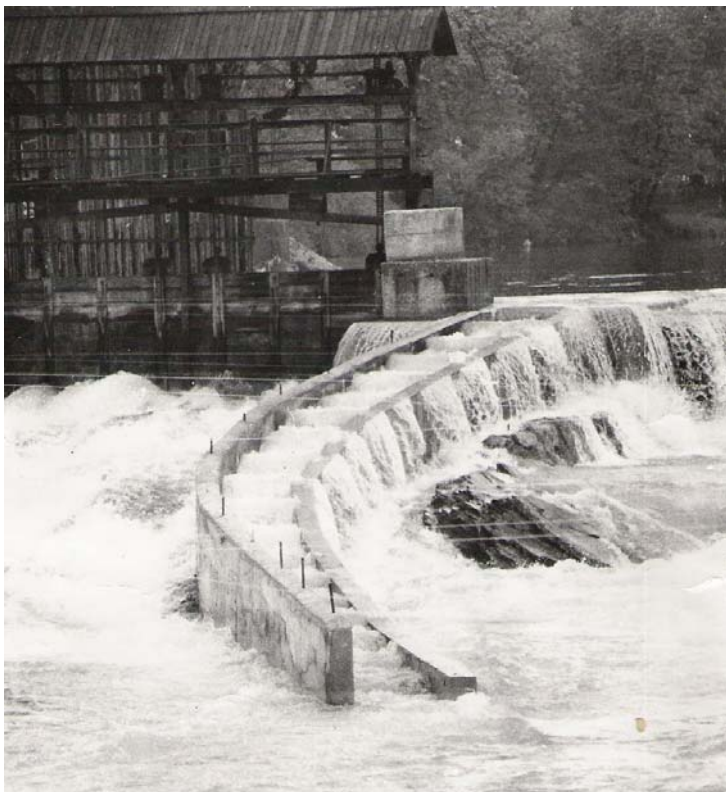
Figure 1: Sava River at Tacen, unfunctional fish way, situation in 1982.

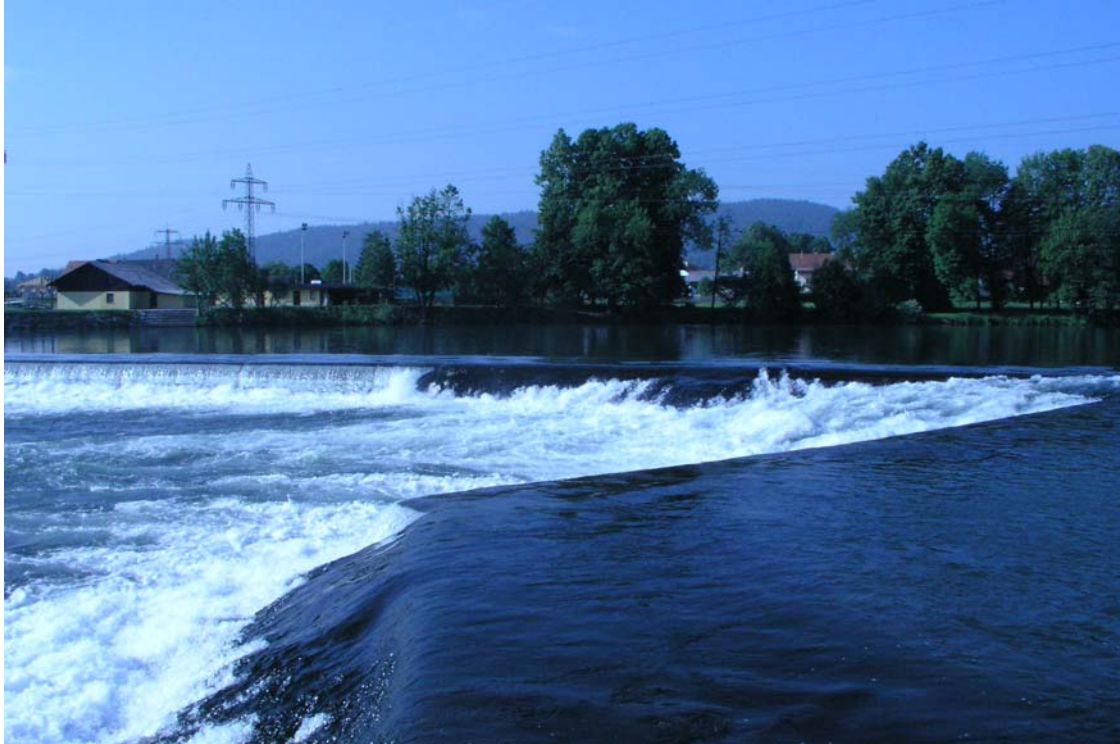
Figure 2: Sava River at Tacen, rocky glide, situation in 2006.

- Reconstruction of old dam
- Removing and replacement of unfunctional existing fishway with rocky glide

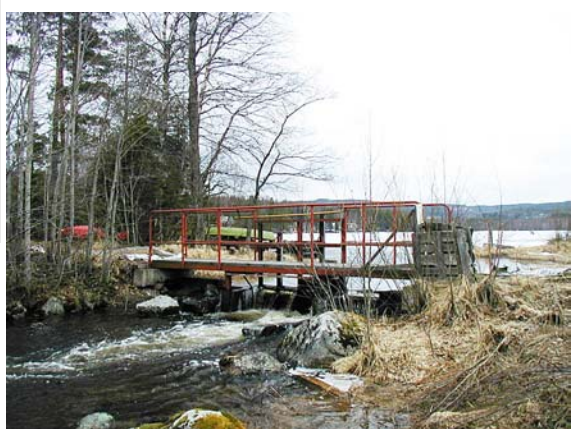
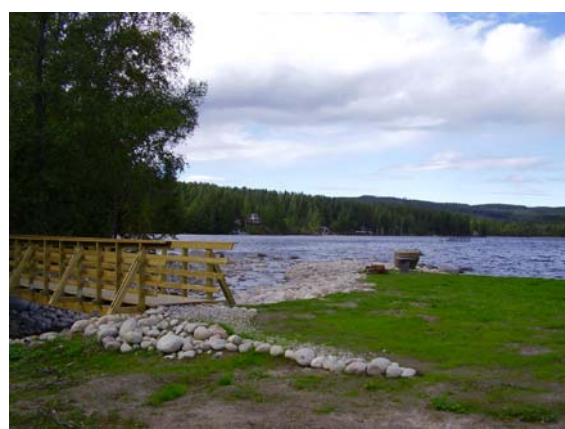
Figure 1: The pictures show the outlet of Storsjön before (to the left) and after (to the right) reconstruction of the natural outlet of the lake. The lake is situated in the upper part of the river basin drainage area. The drainage area of the lake is 33 km² and the mean flow in the outlet is 0.4 m²/s.
