WFD AND HYDROMORPHOLOGICAL PRESSURES

TECHNICAL REPORT

- CASE STUDIES -

Potentially relevant to the improvement of ecological status/ potential by restoration/ mitigation measures

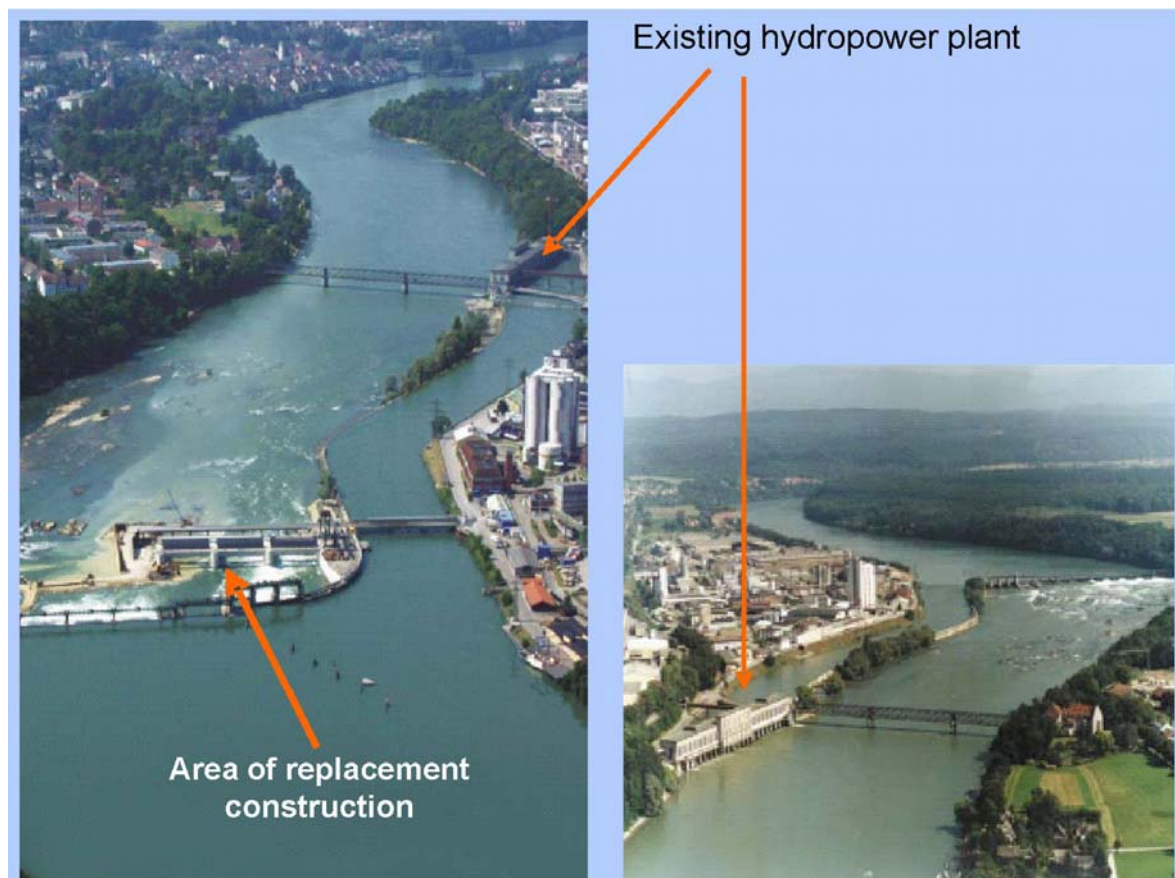
Figure 1: Existing hydropower plant, build in 1898.

- Existing hydropower plant (build in 1898)
 - Design discharge: 600 m³/s, installed capacity: 25.7 MW, annual output: 185 million kWh

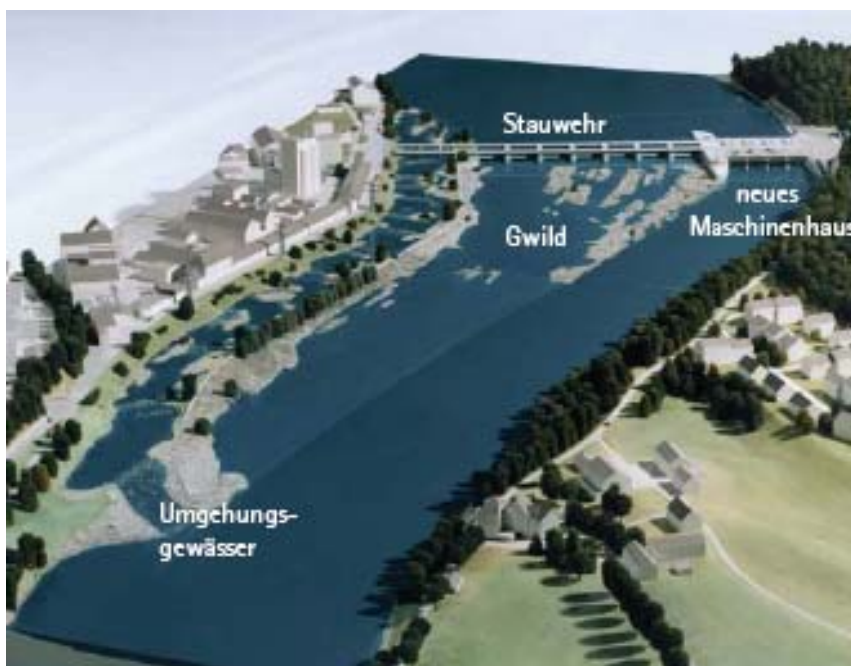
Figure 2: Hydropower plant of the replacement construction (completion in 2011)

- Replacement construction hydropower plant Rheinfelden
- After completing in 2011:
 - Design discharge: 1500 m³/s
 - Installed capacity: 100 MW
 - Annual output: 600 million kWh

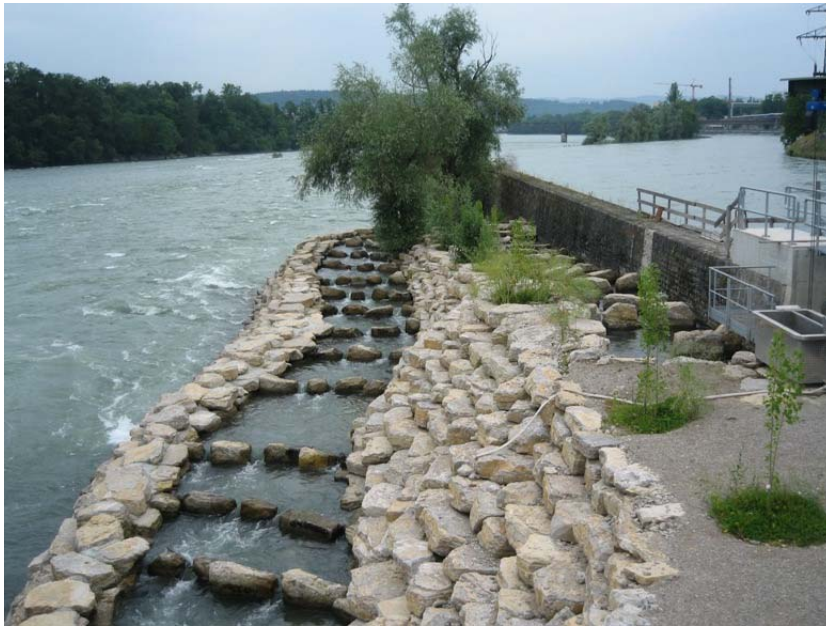
Figure 3: The 150 m long pool fish pass at the new weir.

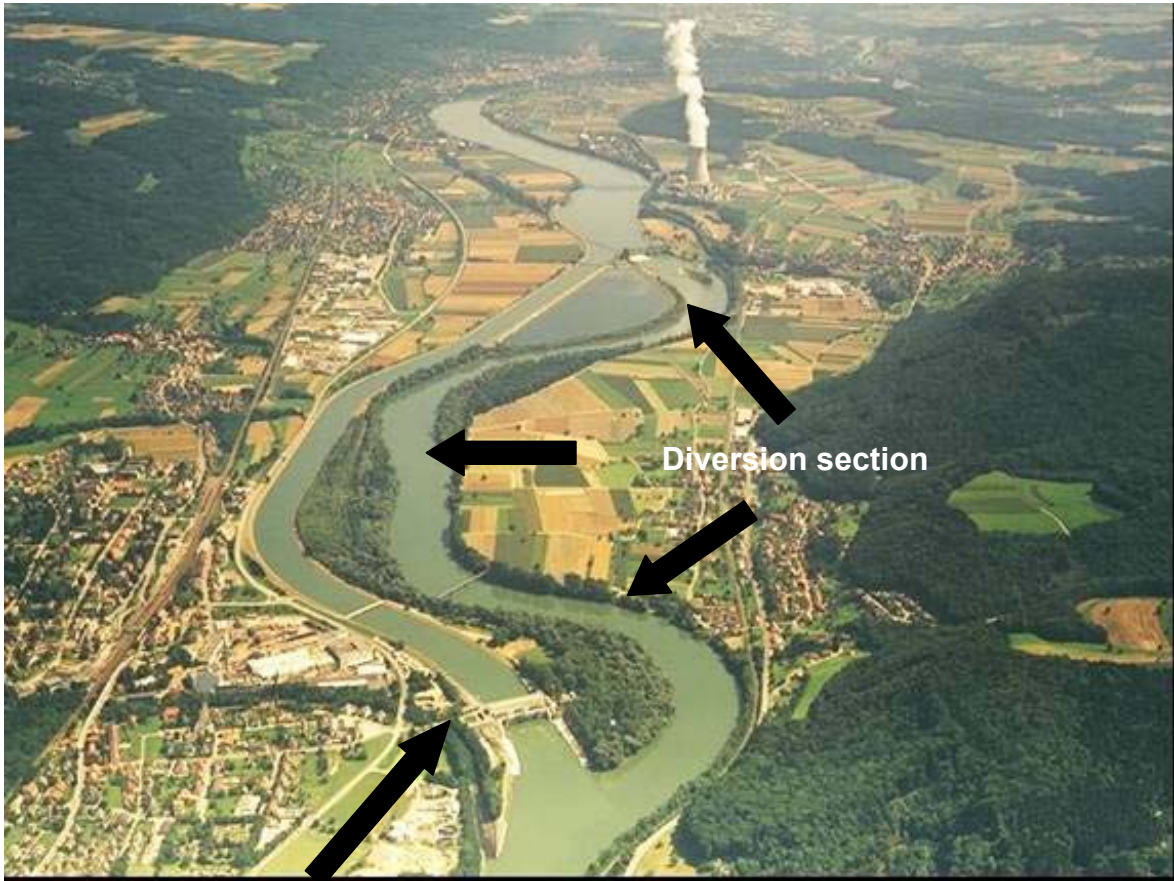
Figure 1: Albrbruck Dogern Hydropower station.

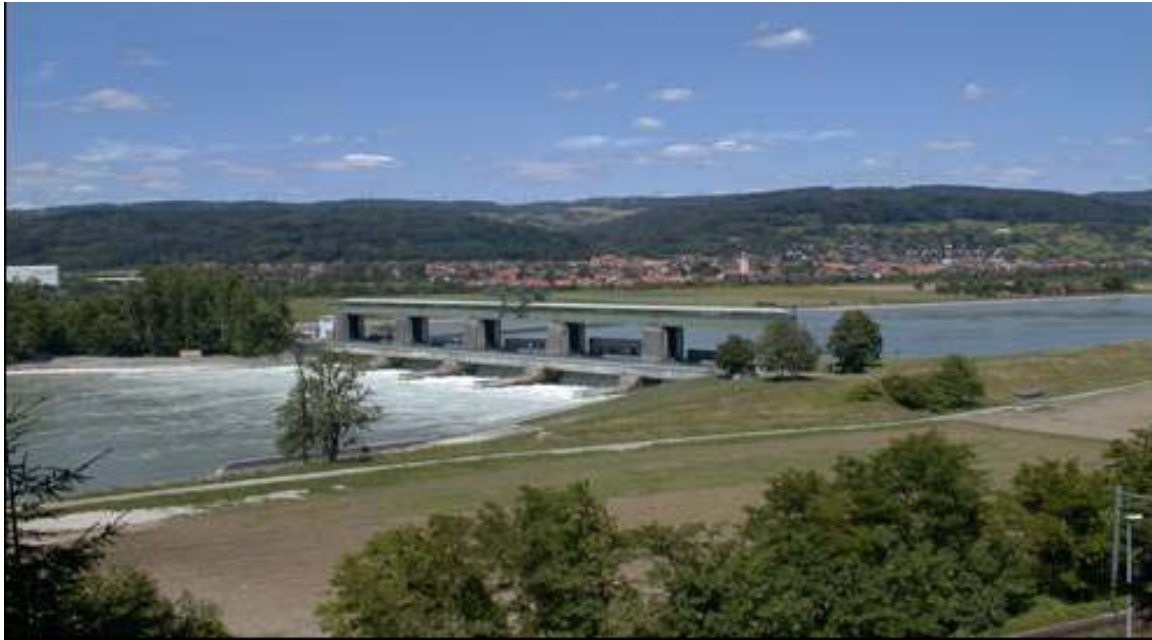
Figure 2: Location of the weir power plant.

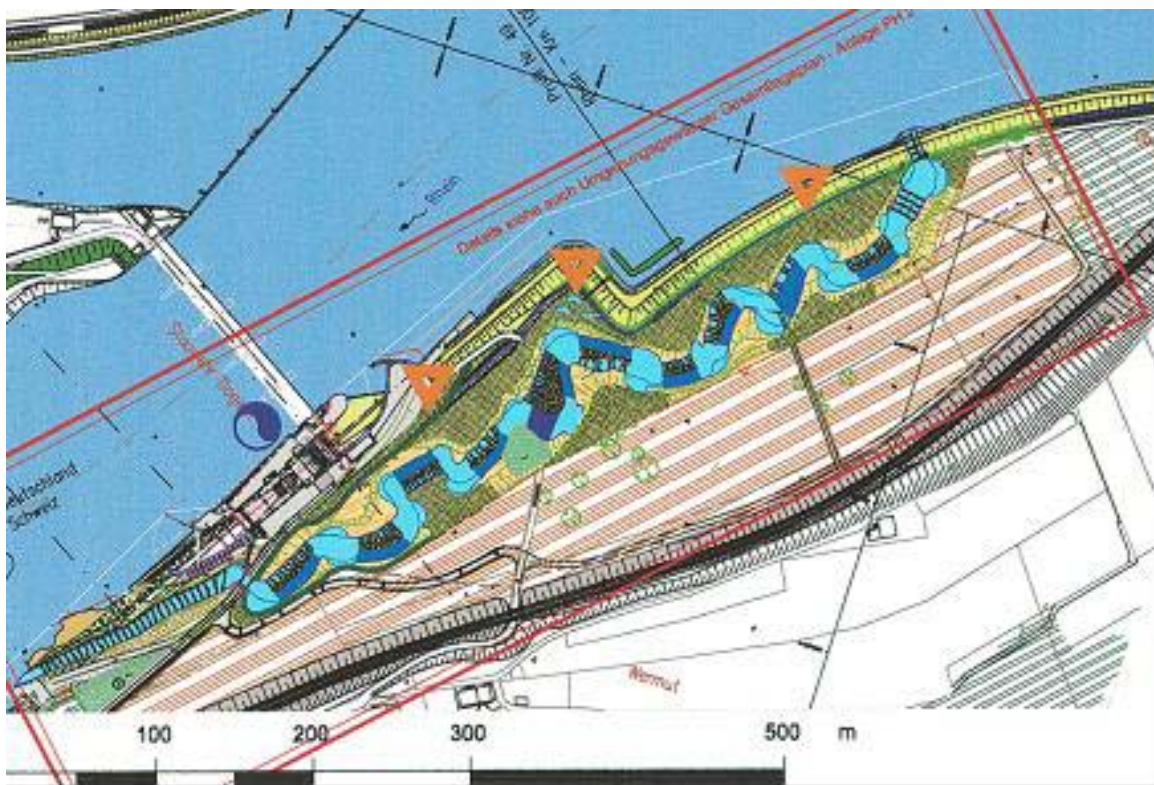
Figure 3: Natural like fish ladder.

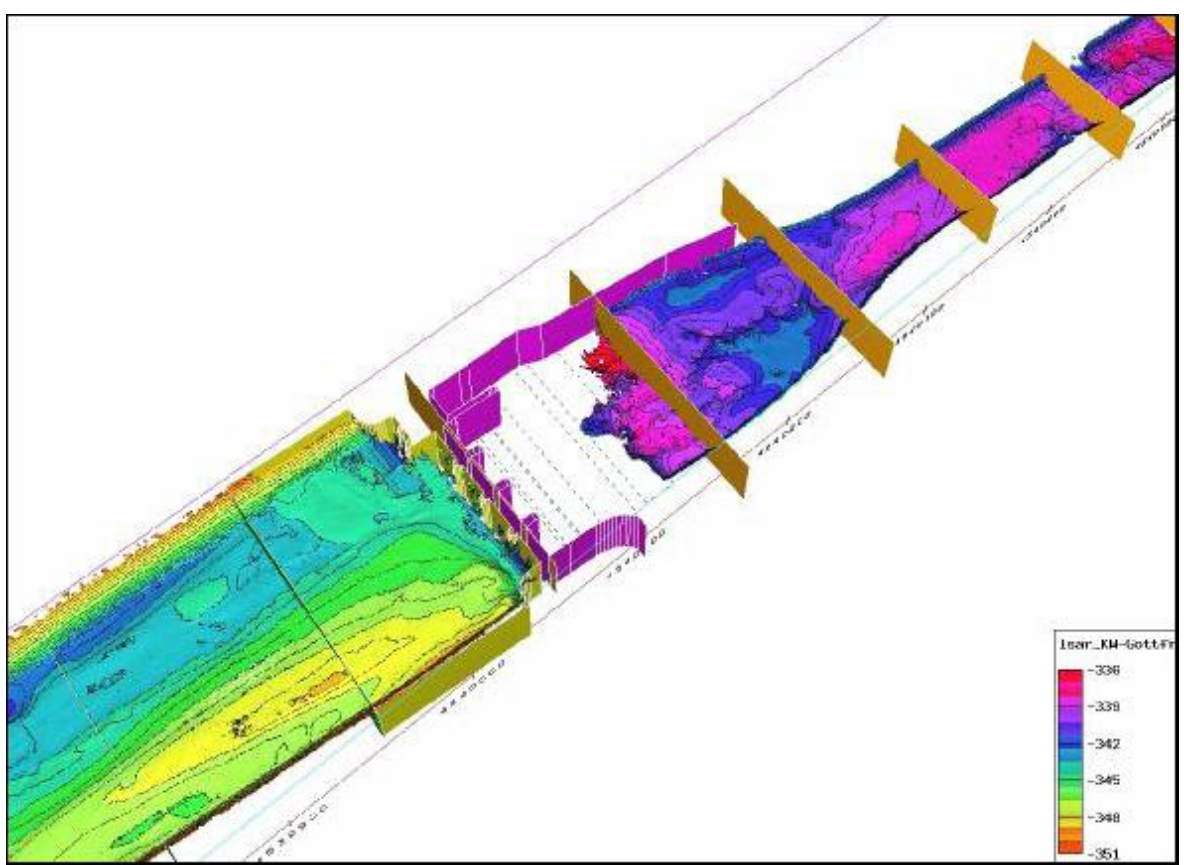
Figure 1: Diagram of the depth-situation between river-km 41.8 and 41.1.

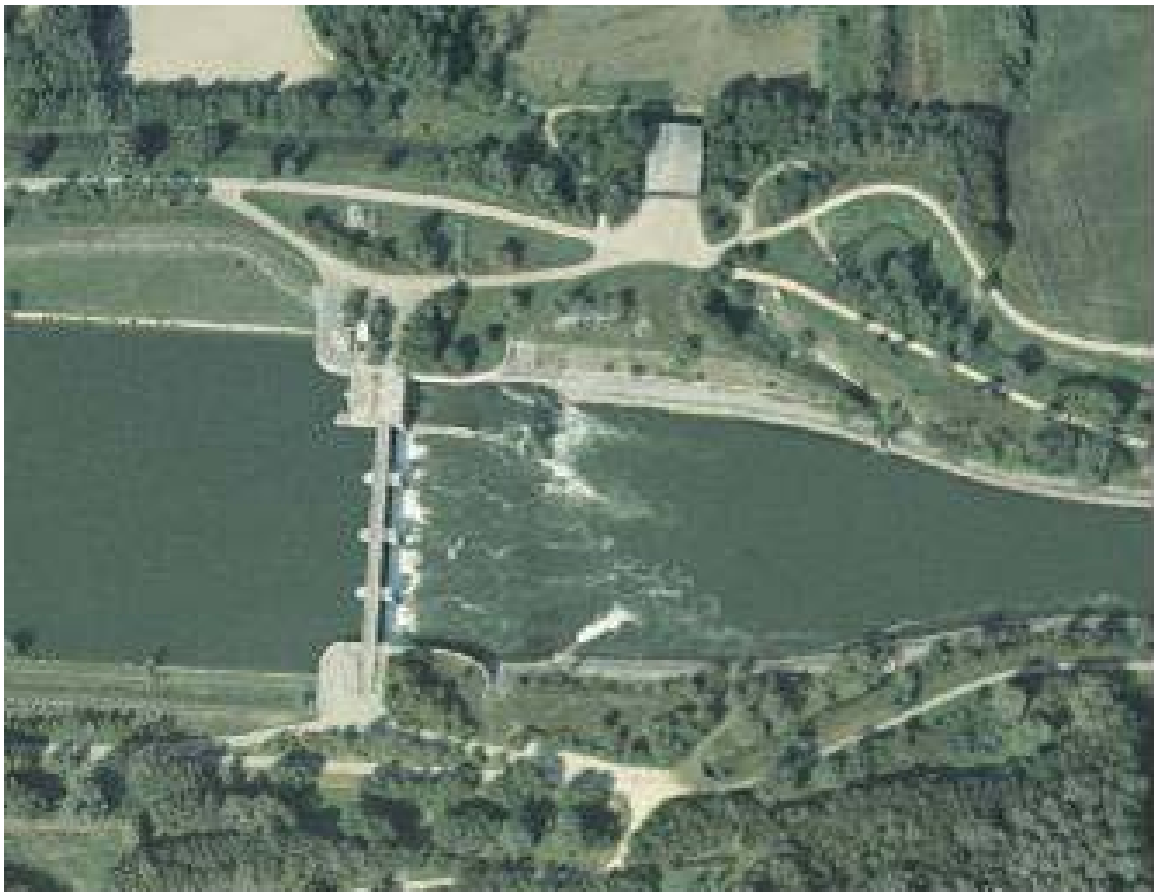
Figure 4: Air photograph of the existing barrage with the electric power plant at the left riverside.

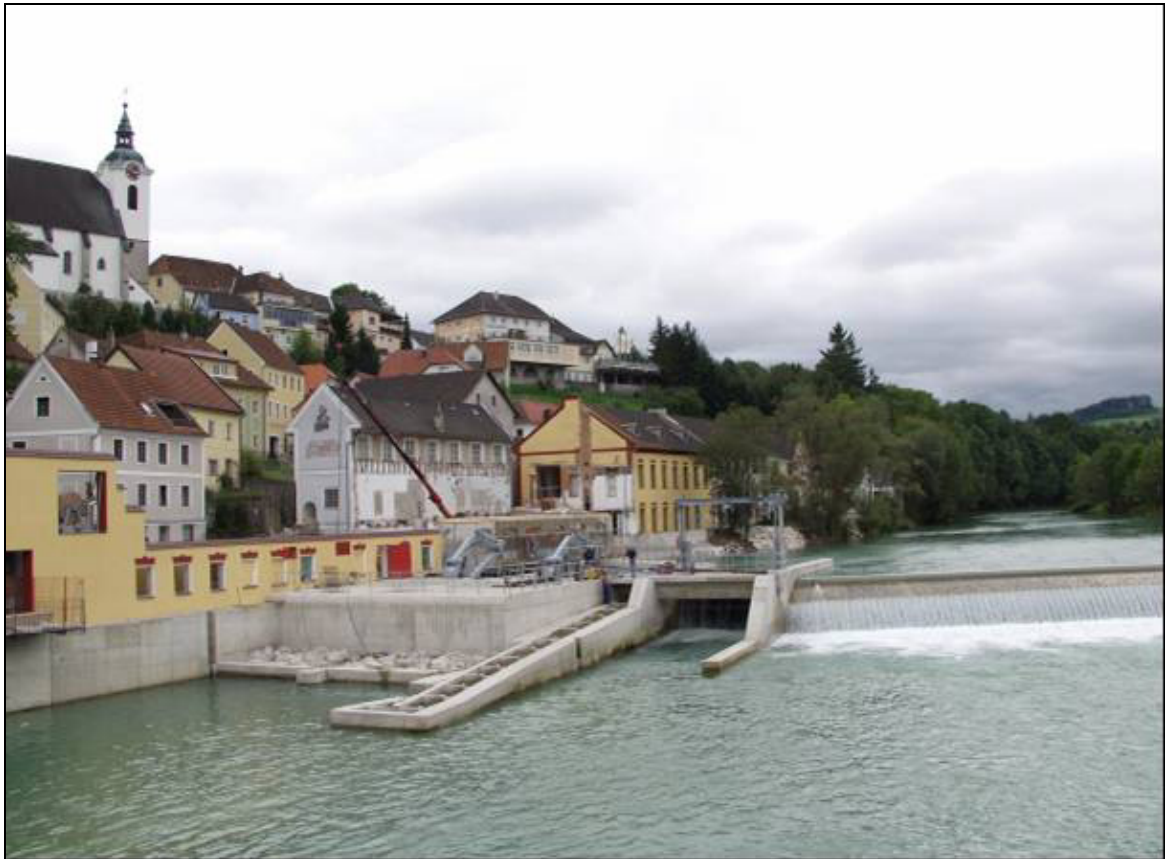
Figure 1: New Steinbach HPP.

- Demolition of old plants and replacement by a single power-house and two generating units. Expanding total discharge from 4.1 m³/s to 50 m³/s and capacity from 100 kW up to 1,100 kW

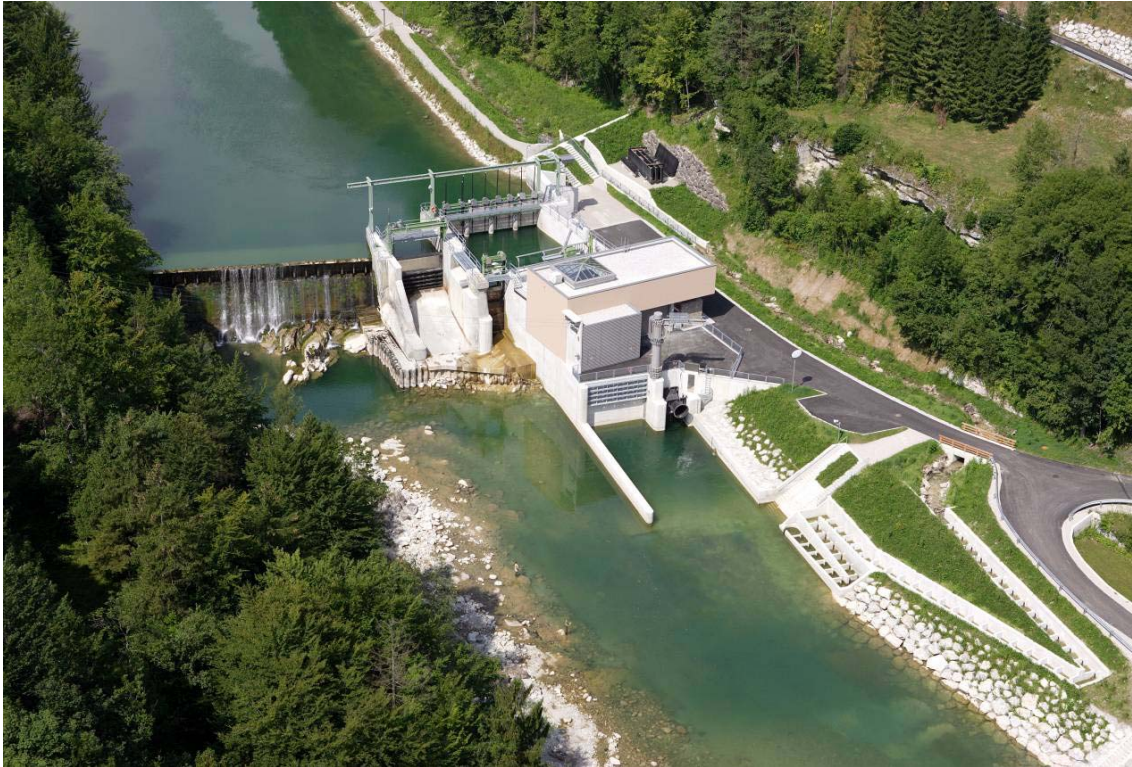
Figure 1: New Agonitz HPP, bird's eye view.

- Due to bad condition and old age of the facility a refurbishment study was carried out in 2001. In conclusion following implementations had been decided:
 - Replacement of power-house and generating units. Expanding discharge from 20 m³/s to 45 m³/s
 - Alteration of bottom weir gate
 - Raising hydraulic head to 8.3 m by 1.3 m bed excavation downstream (Total costs: € 7,600,000.-)
- Expanded discharge and more hydraulic head have permitted an average annual energy production of 15.8 GWh - more than twice the amount before refurbishment.
- Ecological measures were performed by limnology professionals who also assisted the construction works.

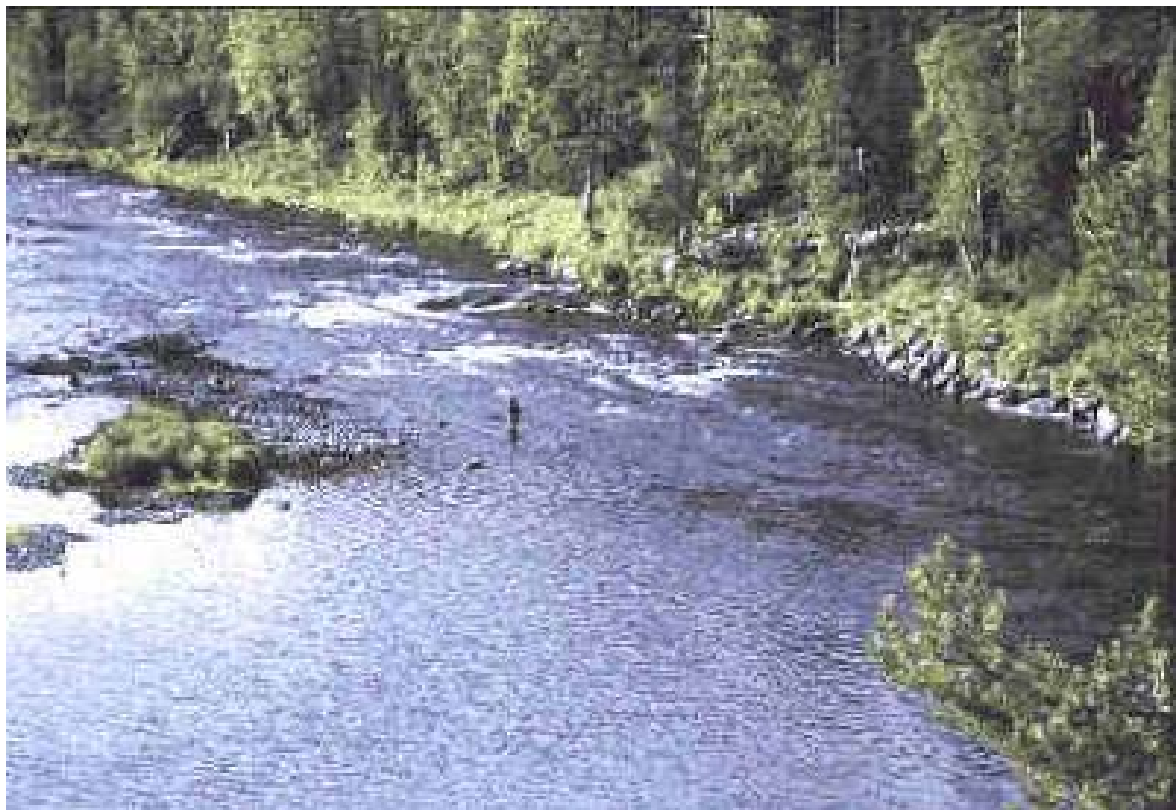
Figure 1: Takkupyörre downstreams of the Myllykoski power plant.

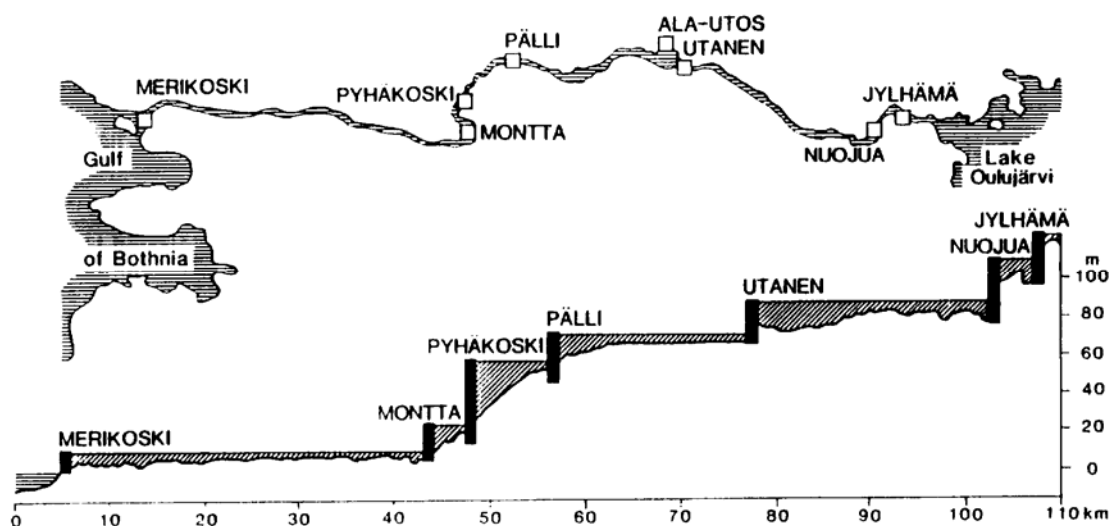
Figure 1: Schematic picture of the River Oulujoki and the power plants.

- The River Oulujoki is efficiently built for hydropower production. The seven power plants are using almost all of the 122 m natural head loss at the distance of 110 km between Lake Oulujärvi and the sea. The plants have small water reservoirs. Due to short-term regulation, the discharge varies daily and weekly. Typical summer time variation is between 50 and 250 m³/s and specified flow rate 450 m³/s.

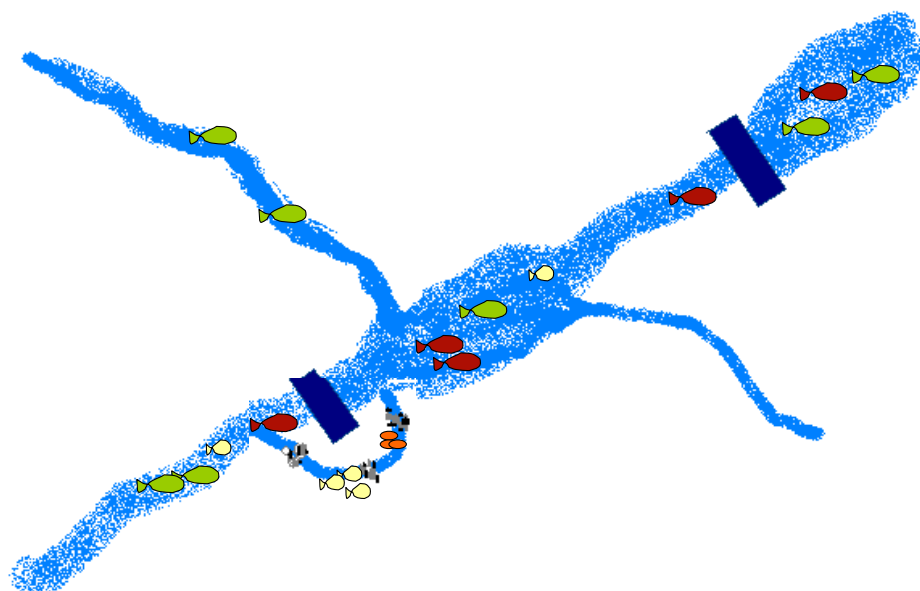
Figure 2: Schematic picture of the bypass channel in one power plant.

- Building bypass channels to the six power plants has been considered in a preliminary study. The aim would be to create rapid-like stream habitat in the river and allow access to the upper reaches and tributaries.

- Effect on the use due to the loss of water. The six bypass channels with 2 - 5 m³/s discharge would cause energy loss of 2 - 4.8 MW which equals 18 - 45 GWh.

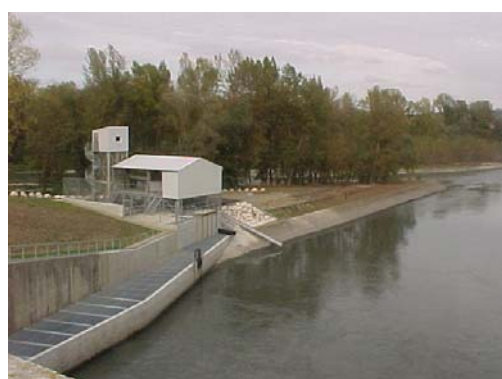
Figure 1: Left:
The downstream capture site for transport upstream.

- Construction of capture sites on the Garonne river
 - In the lower part (Carbonne) to catch and transport (by van) migrating species to an upstream site, from which they swim up to adapted spawning areas
 - In the upper part (Camon) to catch and transport (by van) migrating species to a downstream site, from which they swim down to the sea

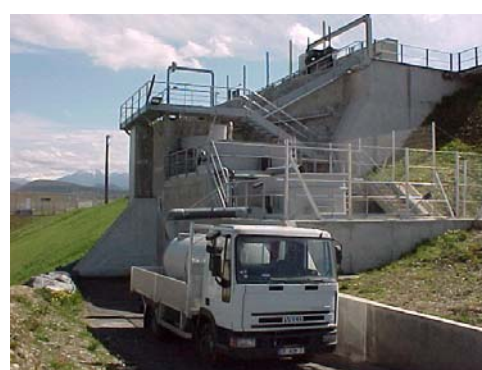
Right:
The upstream capture site for transport downstream.

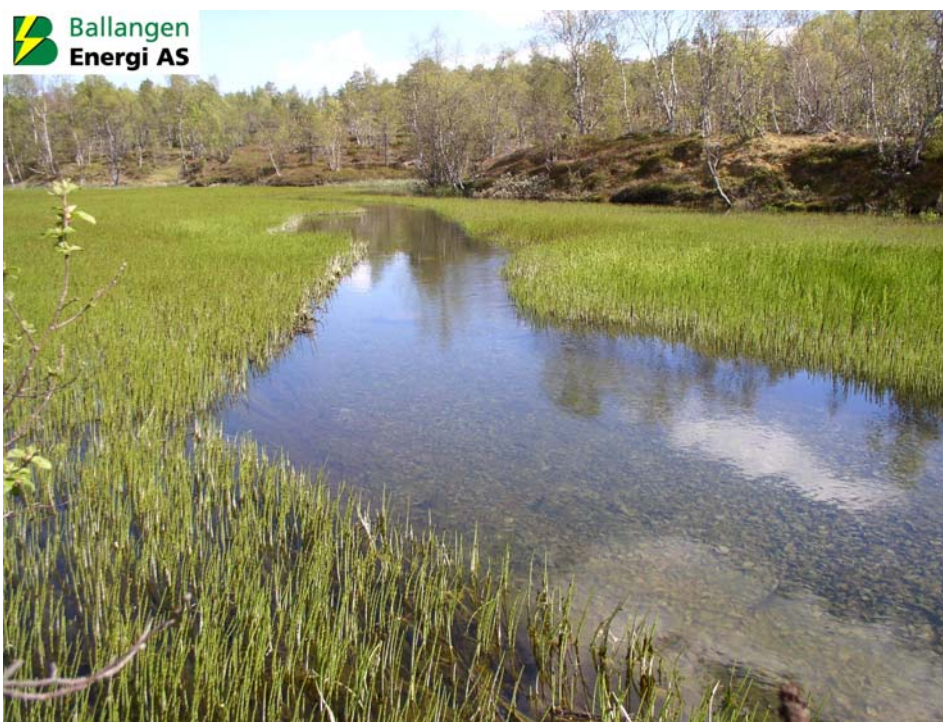
Figure 1: Mesh and gravel are added to create an open stretch through a river profile which originally was totally overgrown by vegetation.

- Further down the river stretch with calm water and overgrowing areas and profiles. A continuous and open river stretch was created. The river stretch was opened partly by digging and by putting mesh and filling the bottom of the river with gravel. Some areas were also added with some bigger stones and large woody debris to increase the diversity in current condition and river biota. Moreover, there were build two weirs to raise the water level some in the lower part of the river stretch. As a result, a more current flow was established, and at the same time more open water surface and areas covered with water was created. This was important for essential river biota.

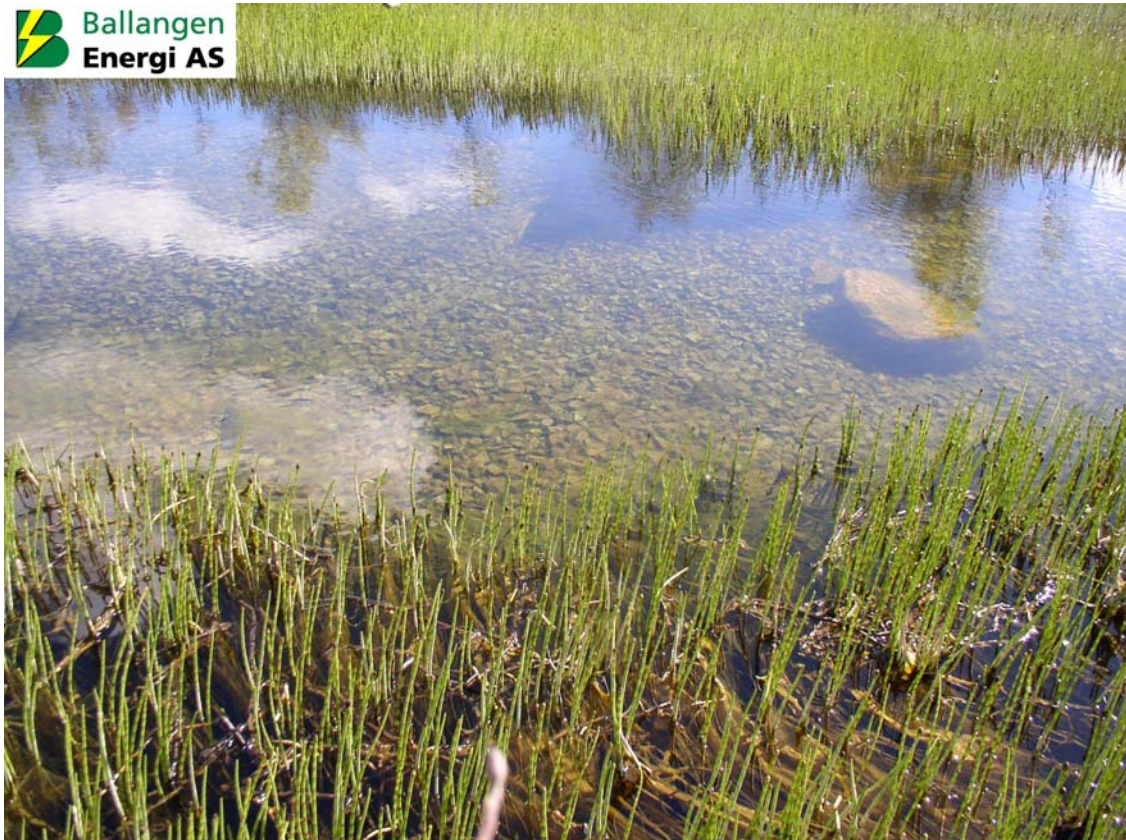
Figure 2: Bigger stones are also added to the river bottom to increase velocity of the flow and to create bigger variety in habitats.

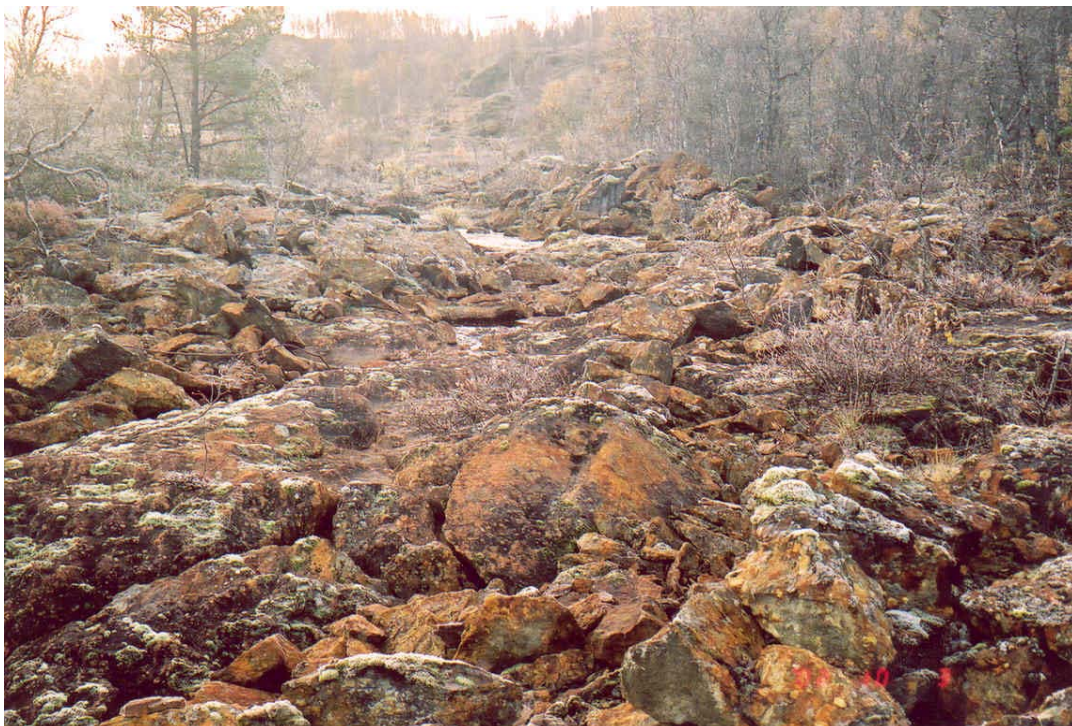
Figure 3: River stretch in the upper part before mitigation. A low amount of water is flowing and the stone embankments are lying along the canalized profile. Done in 1922.

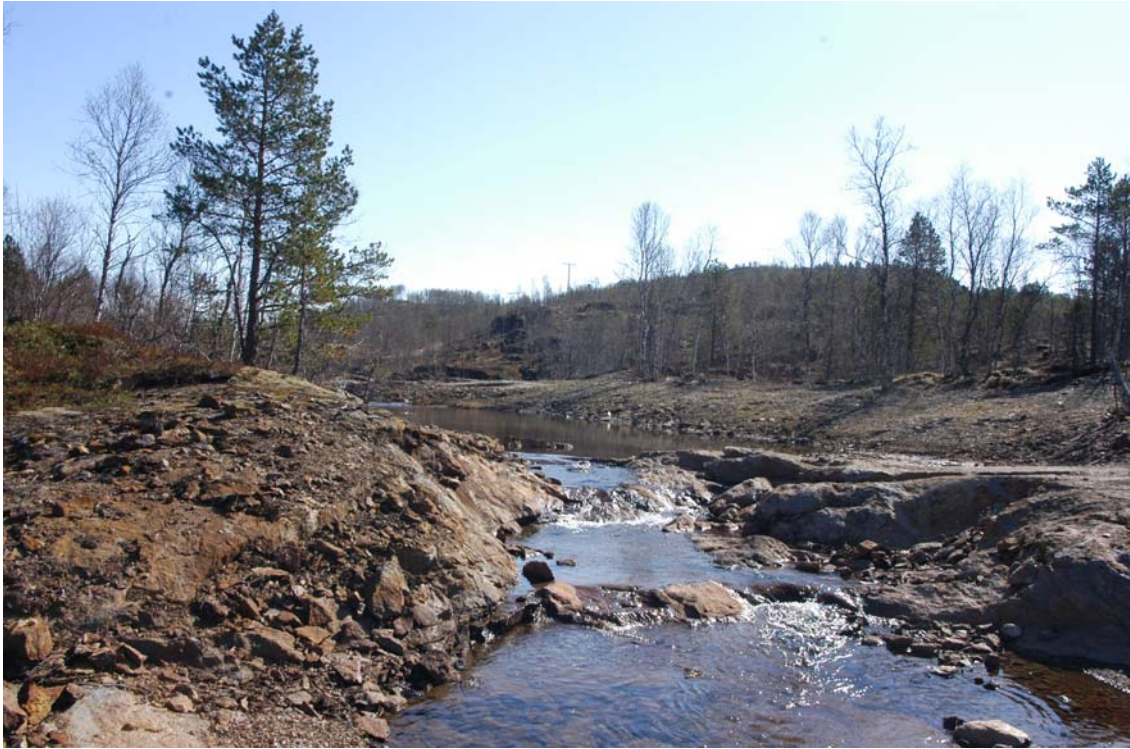
Figure 4: The same river stretch after the new requirement of minimum flow and after creating a new riverbed with pools and moderate runs adapted to the new discharge.

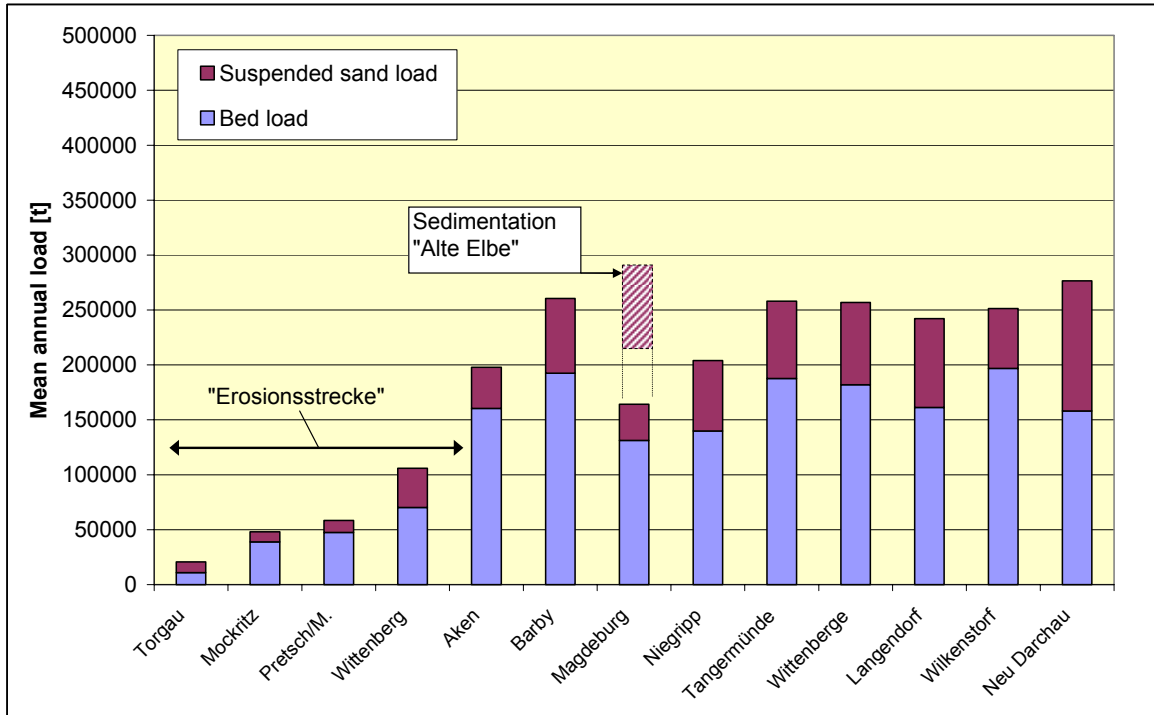
Figure 1: Bed load and suspended sand load in the Elbe River from km 155 (Torgau) to km 536 (Neu Darchau).

- Narrowing of the floodplain and river training by groynes have increased the sediment transport capacity of the free flowing river. On the other hand the impounding of the upper course by weirs has drastically reduced the natural bed load supply from upstream.
- The resulting bed degradation due to erosion of bed material is clearly indicated by the increase of bed load and suspended sand load between Torgau and Barby (cf. Figure 1).

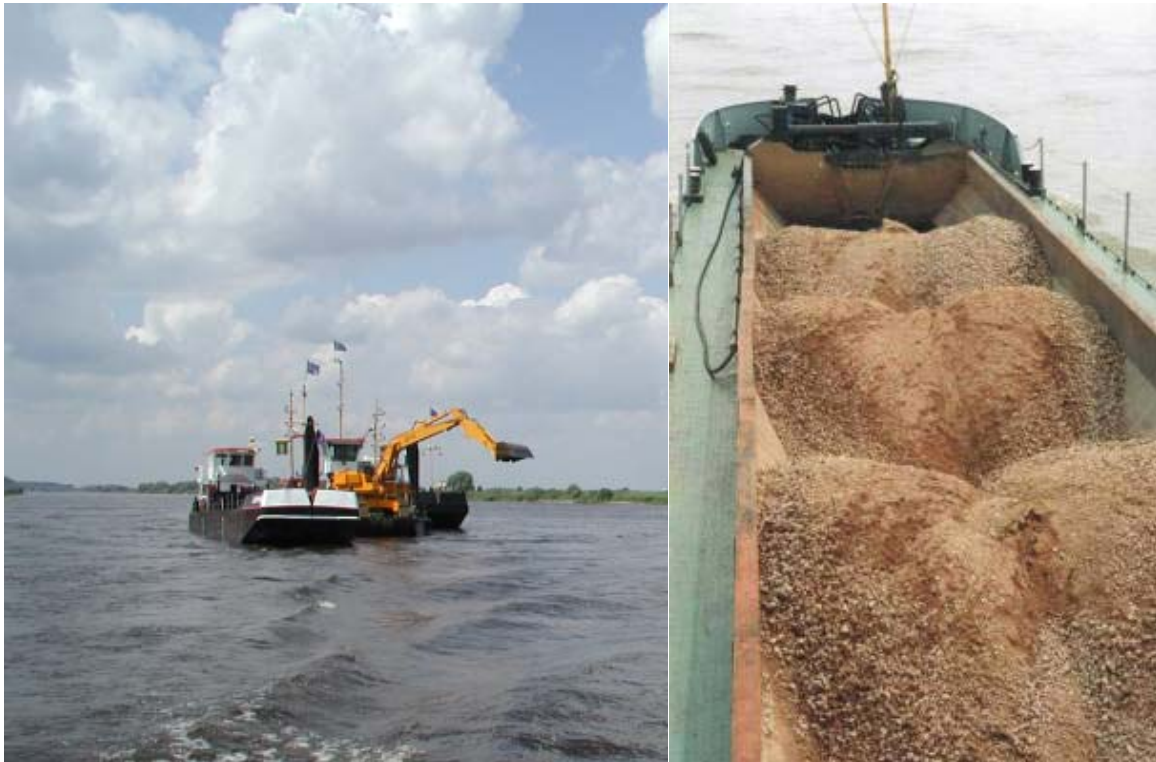
Figure 2: Dredging and dumping of additional bed load into the "Erosionsstrecke" of the Elbe River.

- A dynamic bed stabilization is aimed at by artificial bed load supply at four sites between Elbe-km 153.8 and Elbe-km 193.2. Between 1996 and 2002 all in all 242,000 tons of gravel and sand were dumped by special barges (cf. Figure 2). After a break in 2003 the operation was resumed in 2004. The material dumped originates from both adjacent gravel pits and from dredging sites in the river itself.
- Two tracer tests, one using a petrographic tracer, the other operating with luminescent material allow to quantify the migration velocity of the dumped material.
- Changes of the riverbed morphology are controlled by echo-sounding surveys and modelled by an one dimensional morphodynamic model.

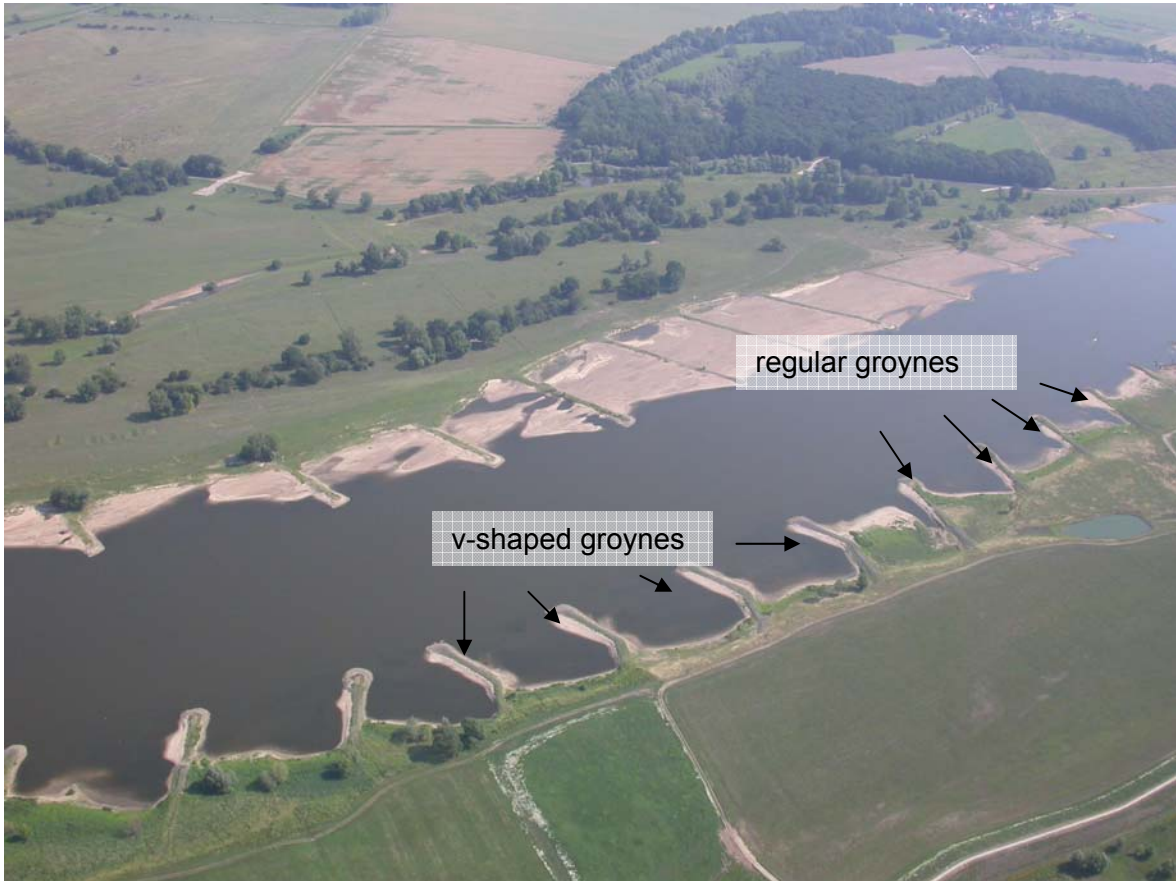
Figure 1: Study site 1 (Elbe-km 440.2 - 441.1) with regular and modified groynes; silted groyne fields.

- Developing and monitoring of alternative groyne forms (cf. Figure 1 and 2):
 - Type I: v-shaped groyne inclined on the bank side and declined on the river side and
 - Type II: inclined groyne lowered by 1.20 m below mean water level on the riverbank sideto induce higher hydromorphological dynamics at the riverbanks.
- Modifying of partially damaged groynes to the new groyne forms within maintenance activities at two study sites in the middle Elbe region. At study site 1 (Elbe-km 440.2 - 441.1) four type I and two type II groynes were constructed (cf. Figure 1 and 3) and at study site 2 (Elbe- km 443.4 – 444.1), three type II groynes were built.

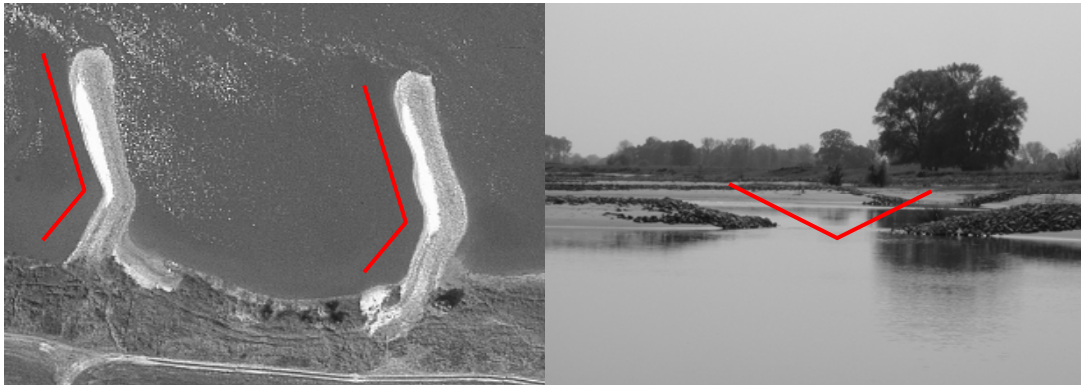
Figure 2: Modified groyne types

Left: type I – v-shaped groyne; Right: type II – lowered groyne

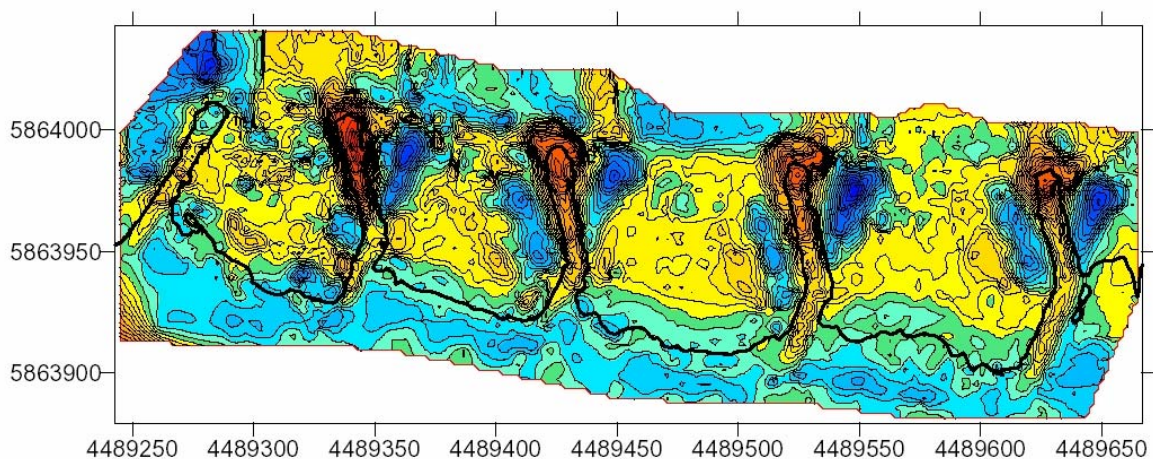
Figure 3: Study site 1 – changes in bed level after groyne modification.

Red areas: increasing bed level; Blue areas: decreasing bed level

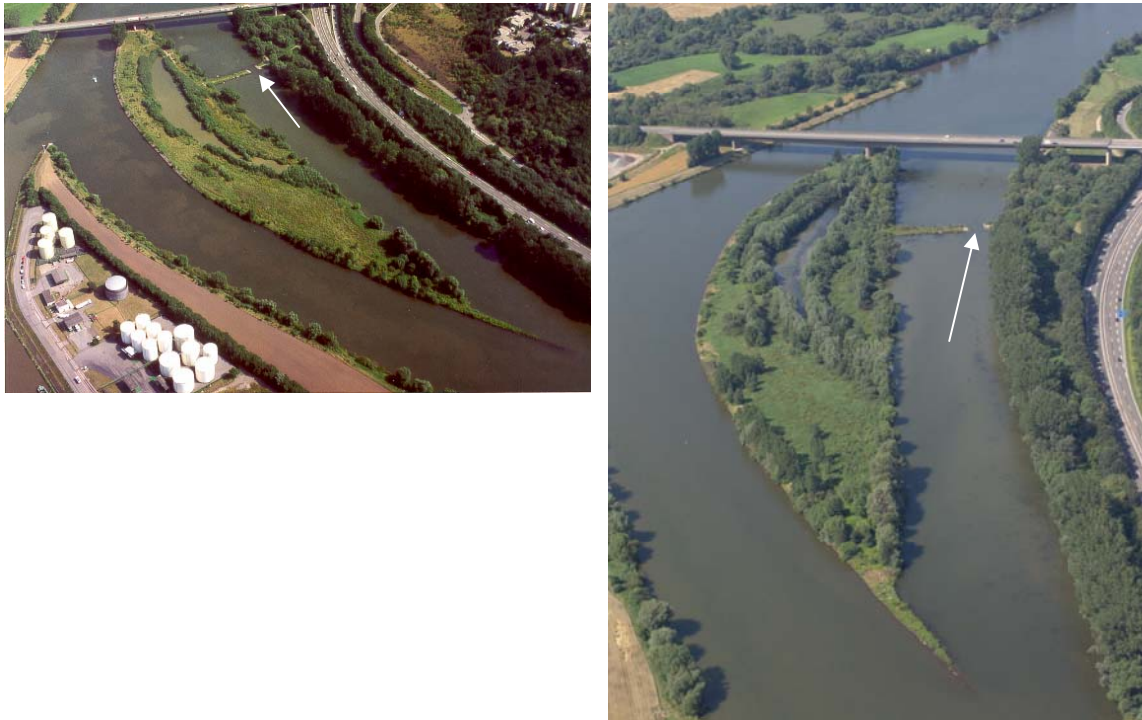
Figure 1: Hahnenwehr floodway (Photo of 1999 left, photo of 2004 right-arrow marks the interrupted courseway).

- Interruption of the causeway (cf. Figure 1)
- Enlargement of the flood spillway and connecting it with the River Moselle for water exchange at mean-flow levels
- Initial planting of typical floodplain trees and shrubs

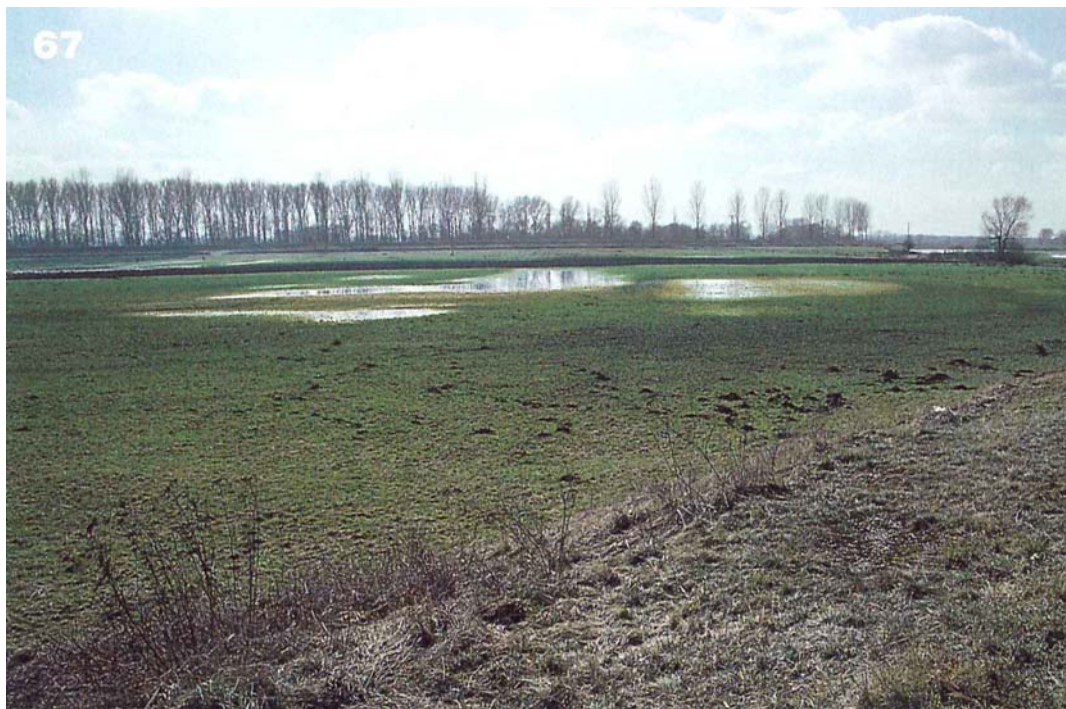
Figure 2: Artificial flooding with influence on the adjacent polder of the Pittricher Wiesen (floodplain meadows) in March 1998.

- Measures taken to preserve the best possible water quality and to prevent eutrophication
- Preserving essential elements of the hydrological dynamics in the floodplain by artificial floods and low-water stages (cf. Figure 2)
- Maintaining a certain influence of seep water on the polder areas behind the dykes
- Preserving the floodplain meadows for breeding birds

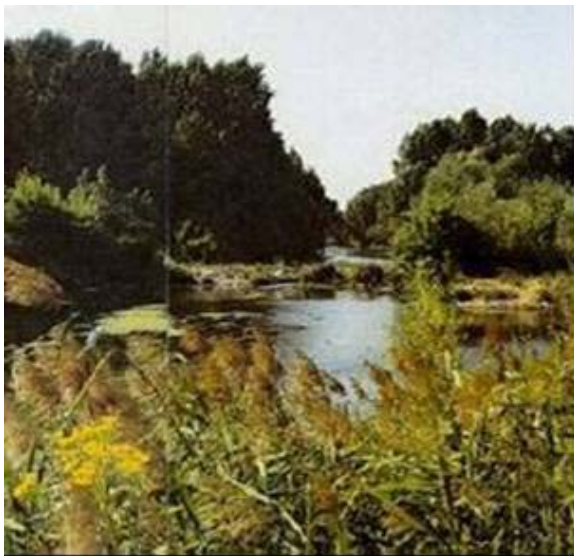
Figure 2: “Giessgang” detail with transverse dyke

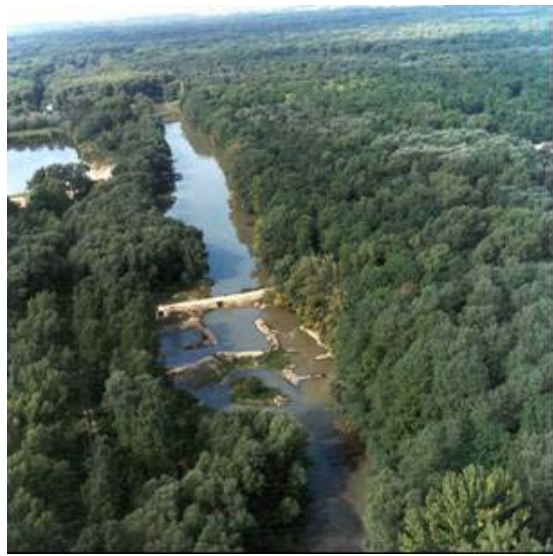
Figure 3: “Giessgang” with transverse dyke (airborn photograph)

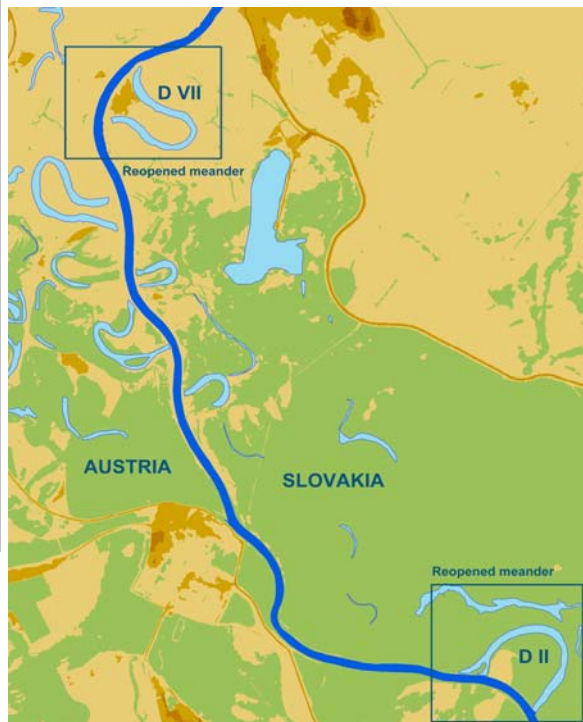
Figure 1: Scheme of the Morava River in the section with reconnected meanders.
