WFD AND HYDROMORPHOLOGICAL PRESSURES

TECHNICAL REPORT

- CASE STUDIES -

Potentially relevant to the improvement of ecological status/ potential by restoration/ mitigation measures

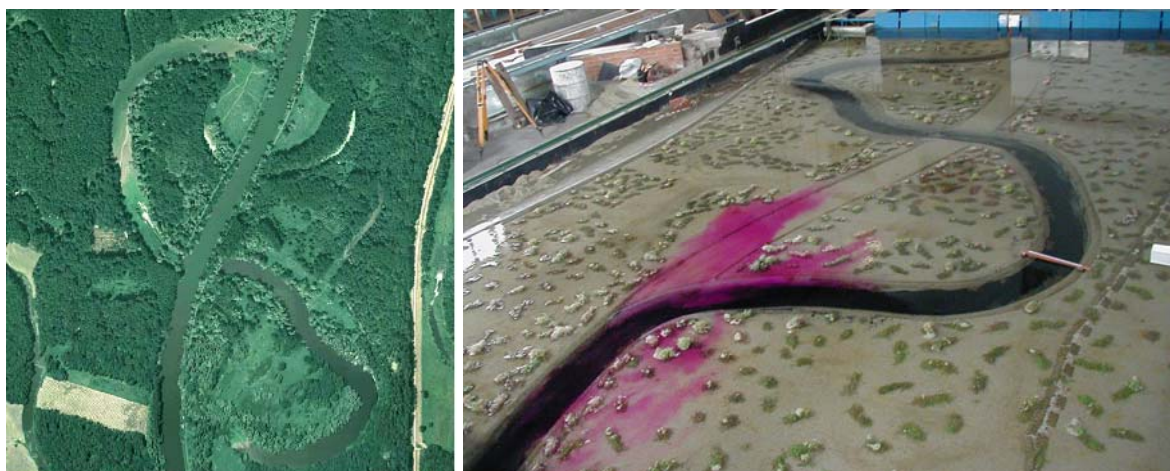
Figure 3: Present state and proposed improvement of the oxbow system on the Morava river (km 63) Current conditions - aerial photograph. Full meander integration – efficiency verification on physical model scenarios were analyzed on the hydraulic physical model.

1. Full meander integration (all flows diverted into meander) implemented in selected localities of the river in order to re-establish the dynamic equilibrium within the river reach. Meander integration would provide the required flow dynamics in the meanders, higher sinuosity and increased channel habitat diversity. This would also enable degraded river bed to be re-established later followed by associated changes in surface and ground

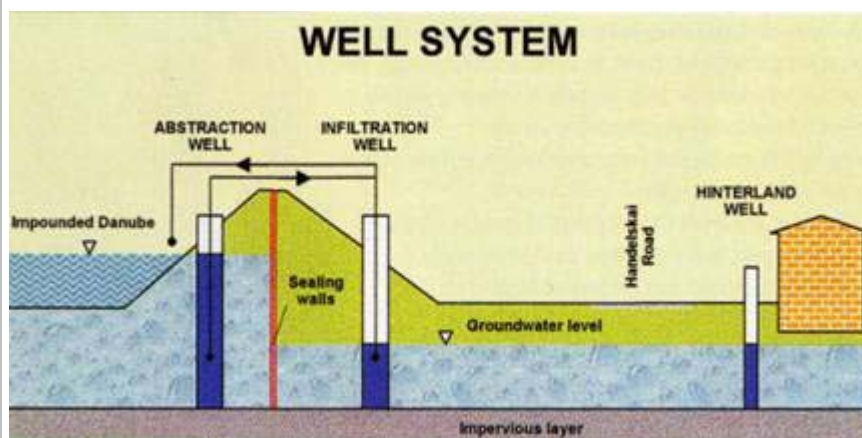
Figure 1: Well system of the groundwater management Freudenuau.

Water management is automatically controlled by means of a mathematical groundwater model to assure the desired water quantity. All data relating to the management system such as water levels, pumping rates and water quality parameters from the on-line monitoring stations are continuously transmitted to the control centre.

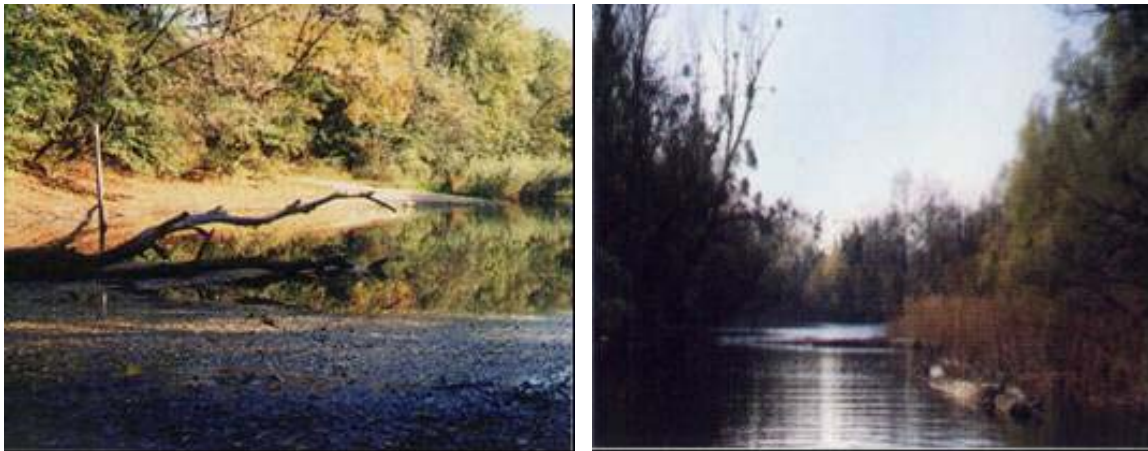
Figure 2: “Mauthnerwasser” in the Prater prior and after the introduction of the water management system.

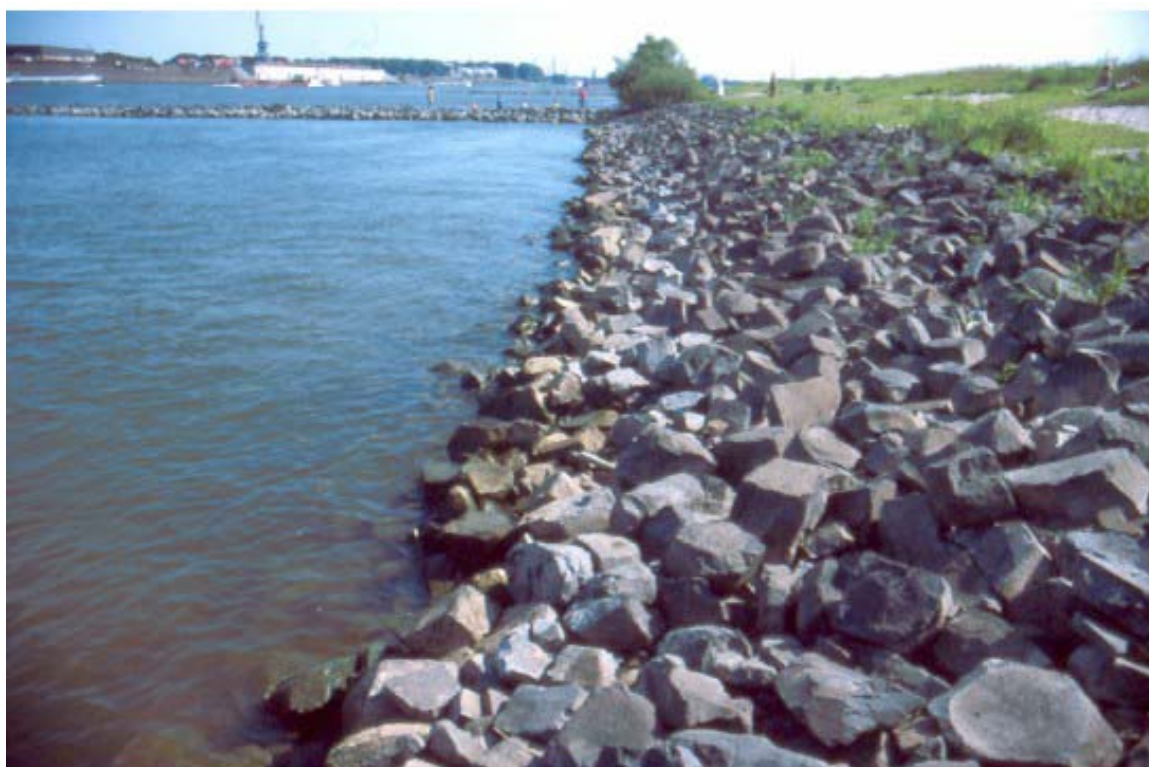
- Continuous stone filling (LD-slag¹); used to stabilize the slip-off slope over a length of 1.4 km; partly with poured groyne (cf. Figure 1)
- A 400 metre wide strip of grassland adjoins the river bank.

Figure 1: River Rhine at Duisburg, bank reinforcement (stone filling).

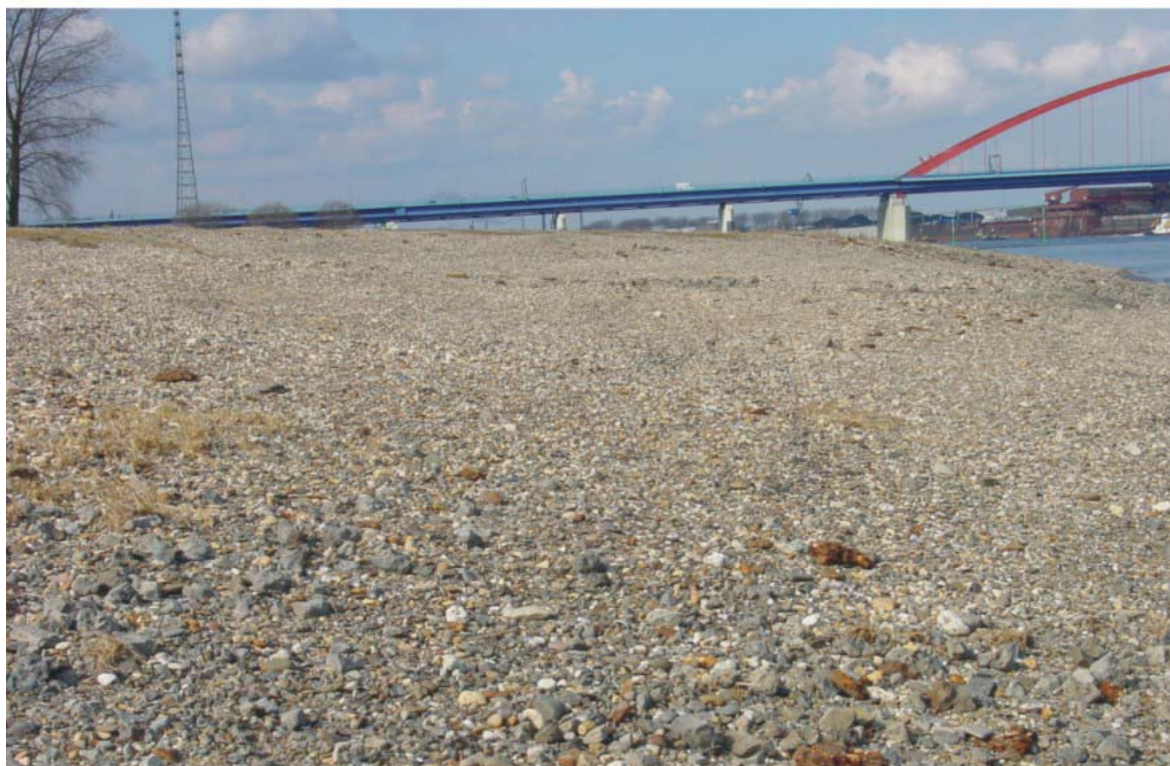
- Removal of the embankment material (building rubbish) at the toe of the groyne fields, which are located at the down stream river bank
- Covering of the LD-slag with a 0.5 m thick gravel layer over a distance of 1.4 km (cf. Figure 2)
- The removal was gradually carried out according to the demand for slag and basalt material, which is used elsewhere for maintenance measures.

Figure 2: River Rhine at Duisburg after morphological improvement; structures will be created by the next floods and should be maintained

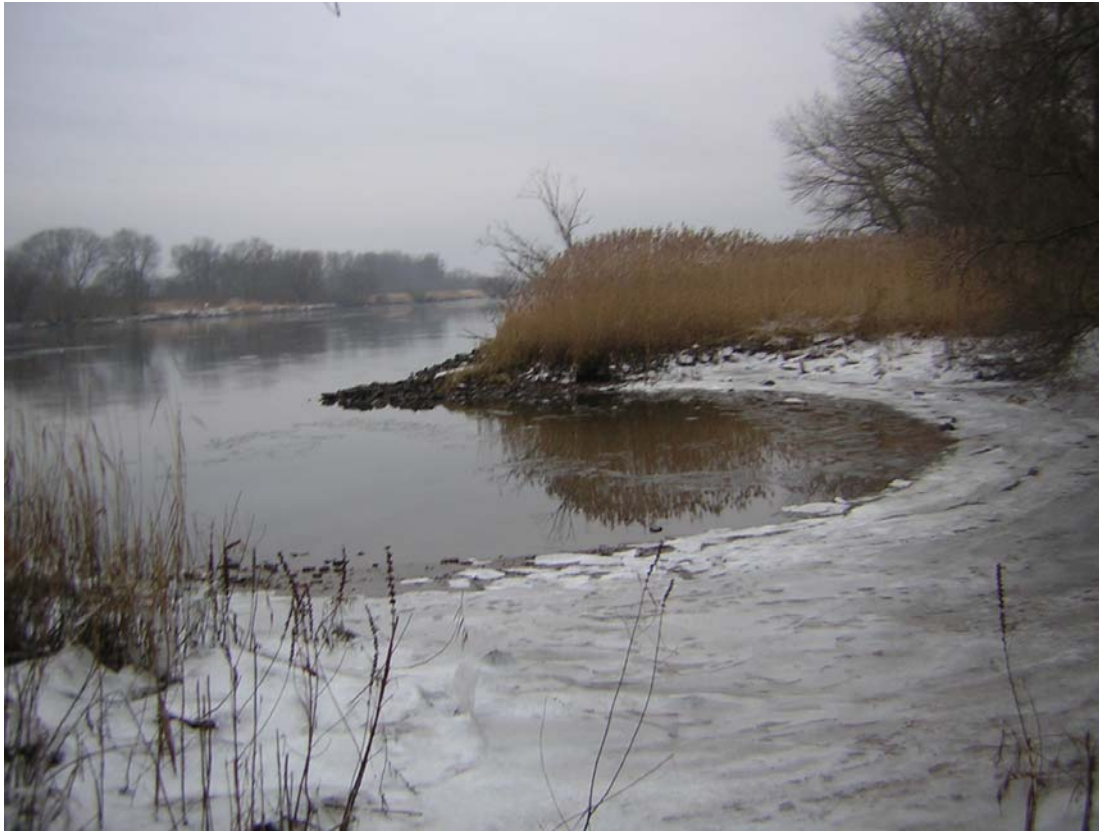
Figure 1: Inlet in the stone filling at the shore of the limnetic tidal river Elbe (January 2006, at low tide).

- The iced area marks the small-scale mud and sand flat, which appears at low tide.
- The course of the interrupted stone filling is visible in the middle of the picture. Approaching from land, tidal reeds infiltrate the stone filling.
- The pictured situation can be found in several sections of the river bank in the natural conservation area “Heukenloch”.

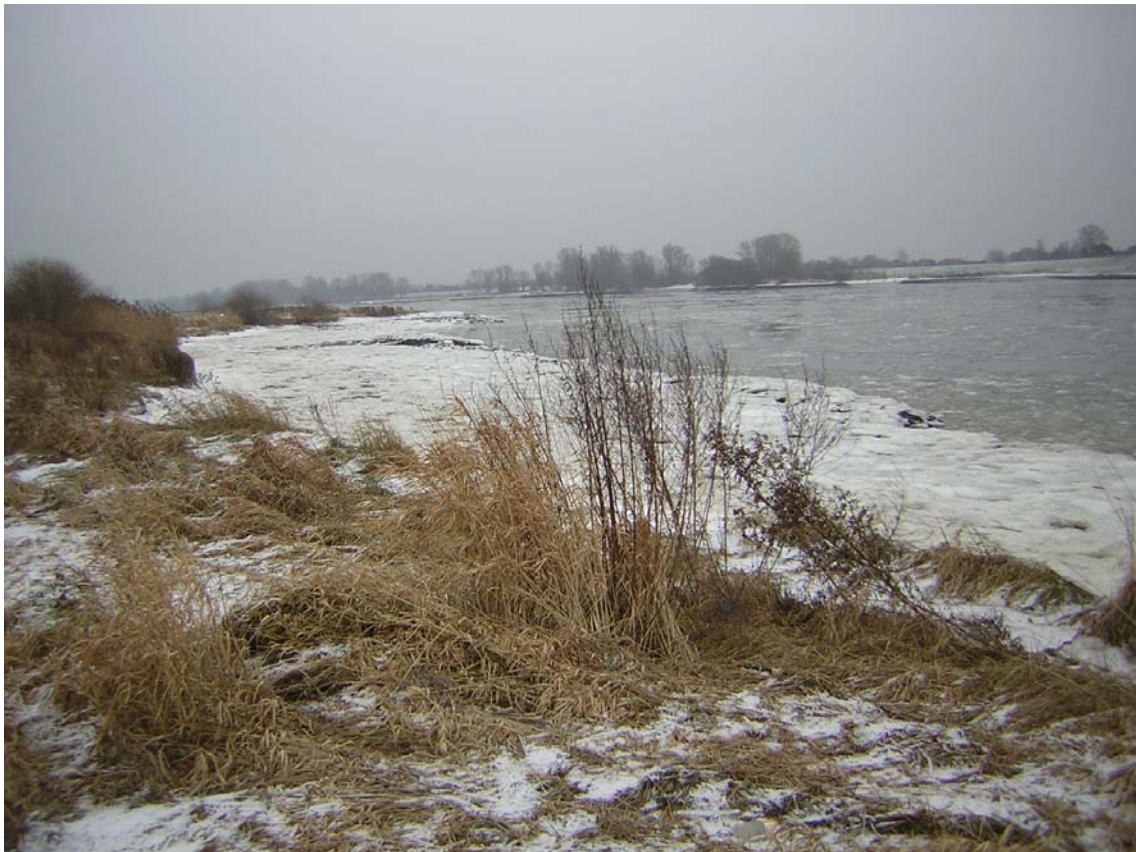
Figure 1: View of a reconstructed section of the river bank (length of section: about 100 m), January 2006 at low tide. The iced marks the zone of the bank which is flooded at high tide.

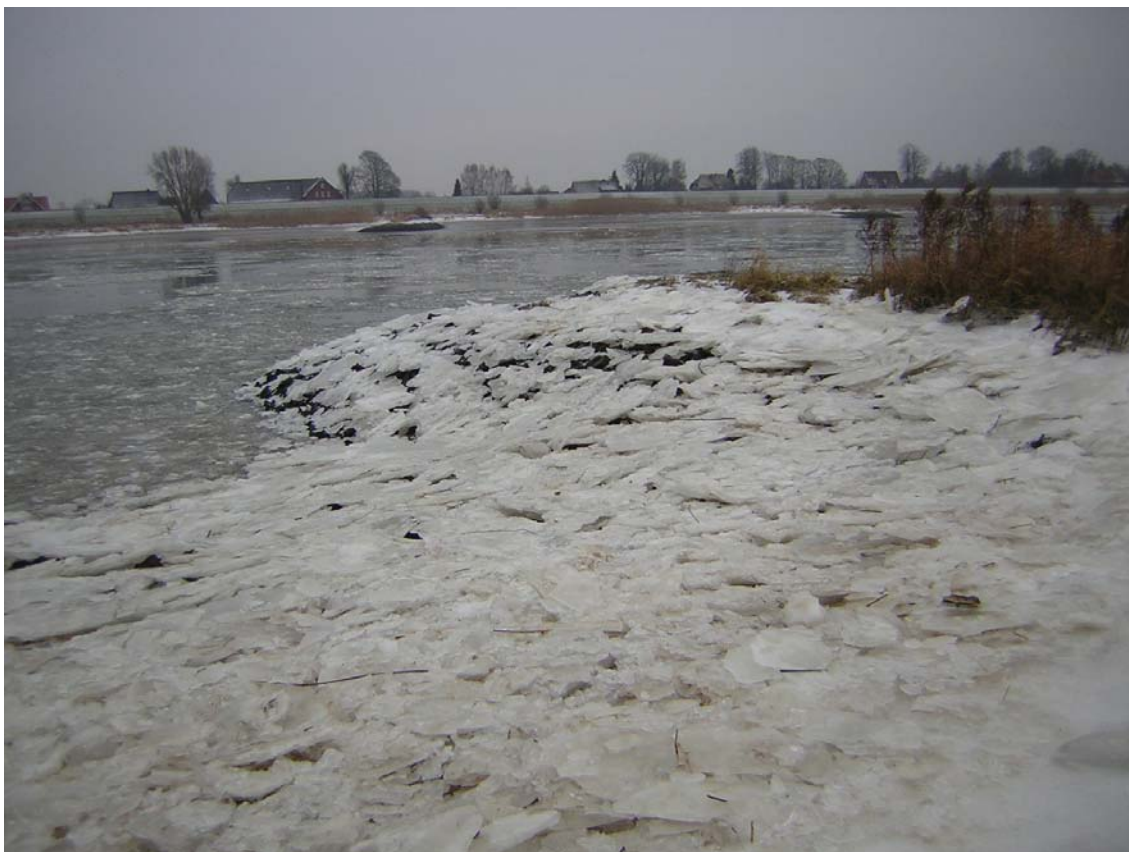
Figure 2: Southern end of the reconstructed revetment. The difference in the design of the bank profile can be noticed clearly.

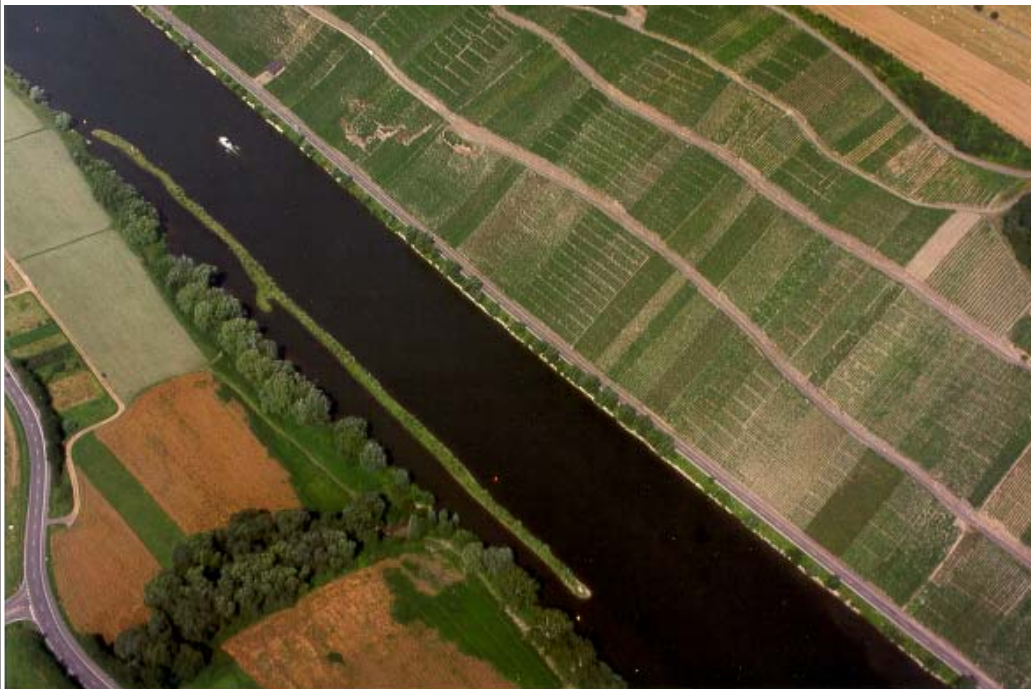
Figure 1: Training wall (Photo of 1999).

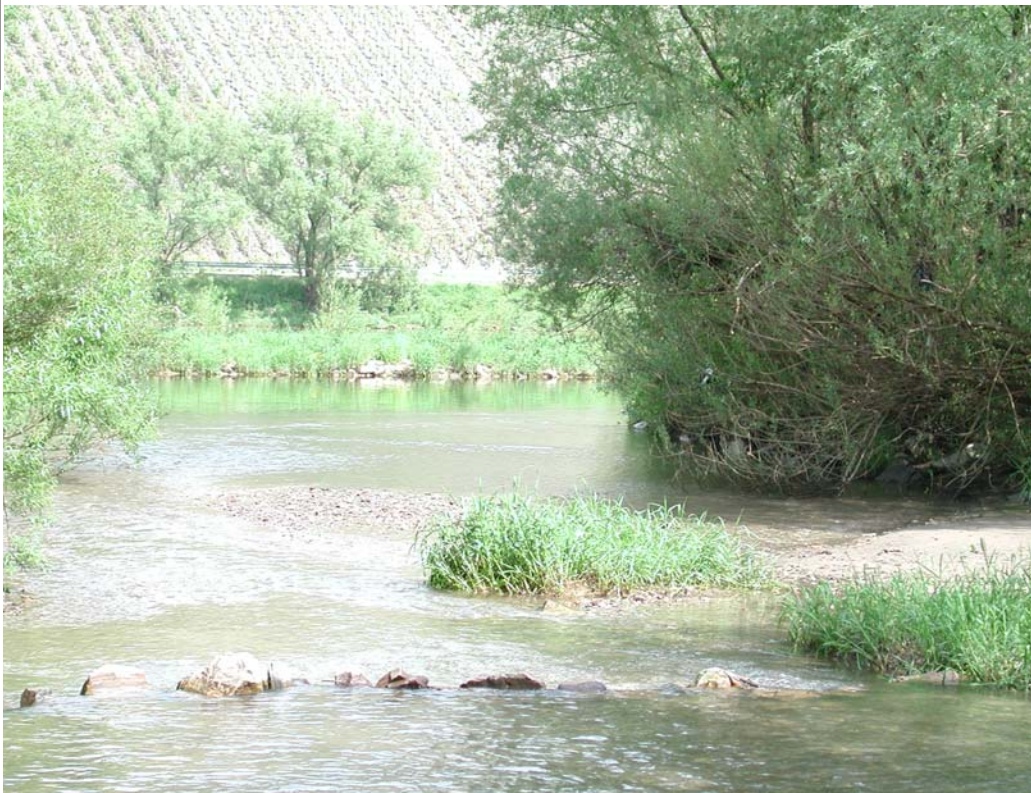
Figure 2: Inflow of a rivulet in the area of the training wall.

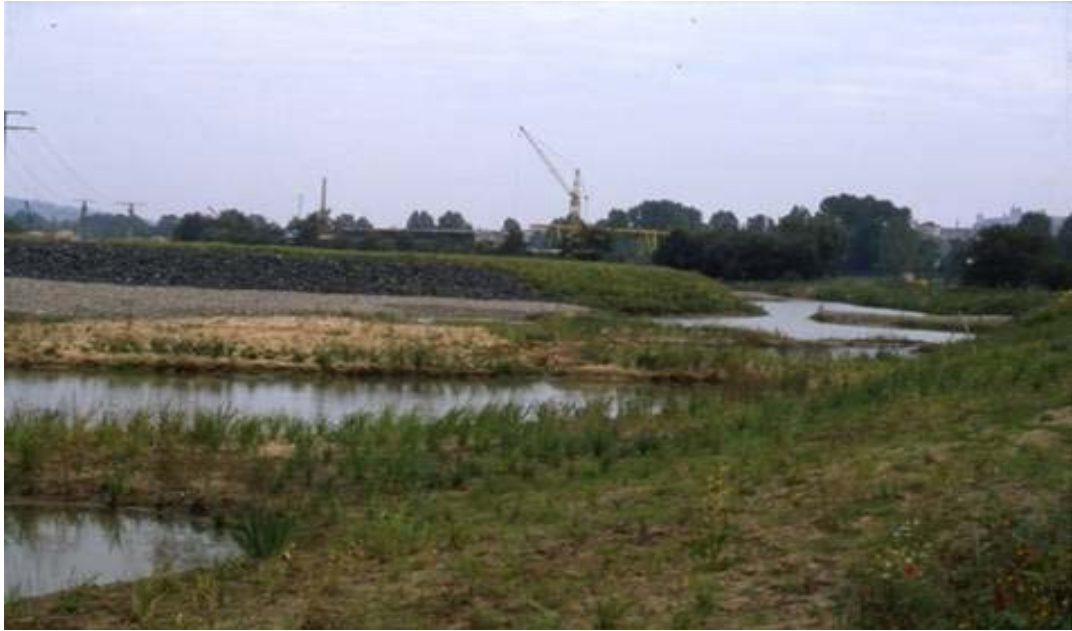
Figure 1: Wetland habitat "Neuer Hafen", a short time after the measure in 1990.

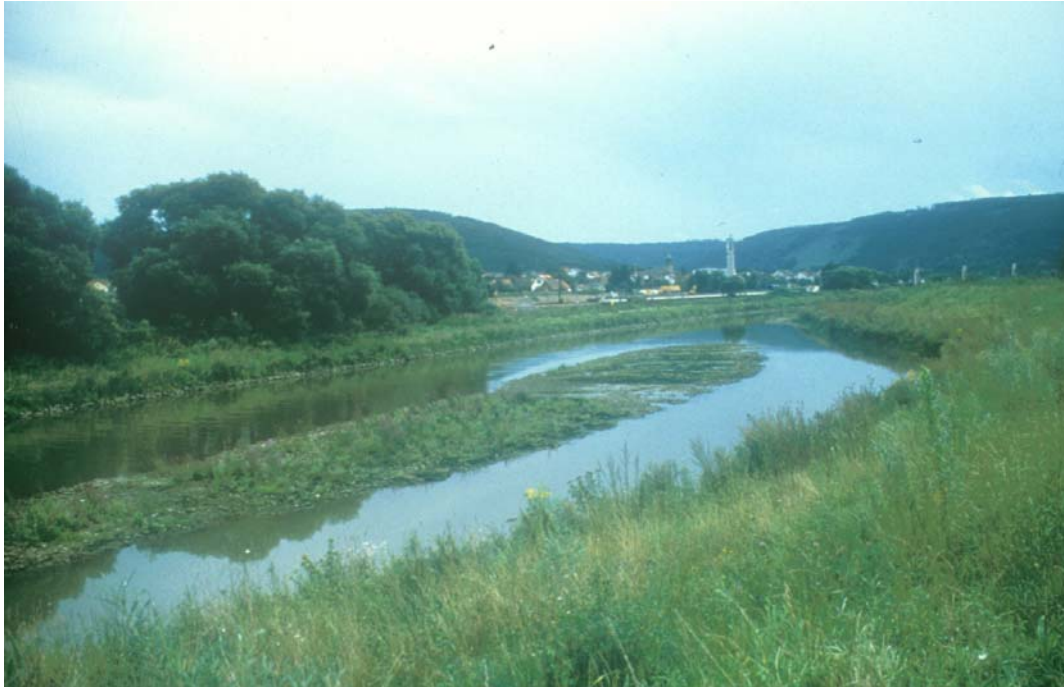
Figure 2: Faulbach, view of the floodway in 1997.

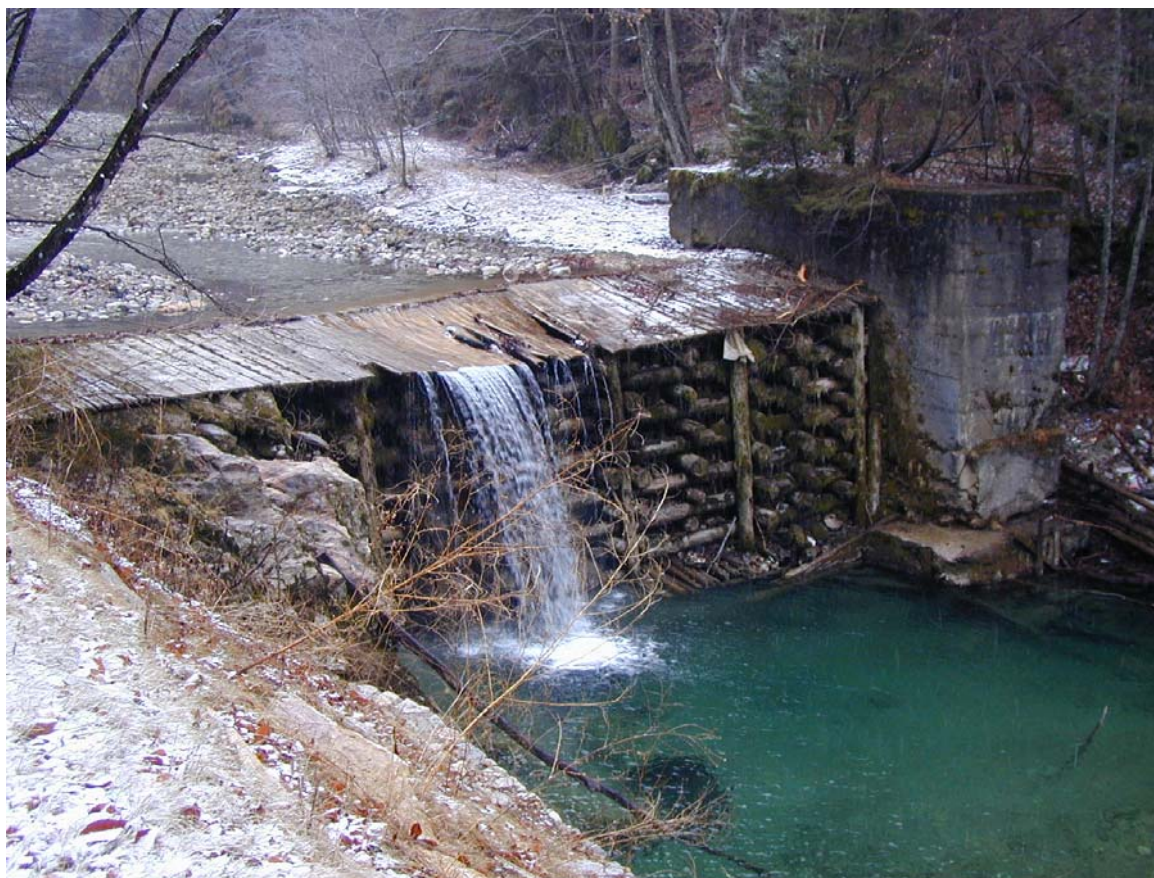
o2
01

Figure 1: Dam on the Kokra River before restoration works, situation in 2002.

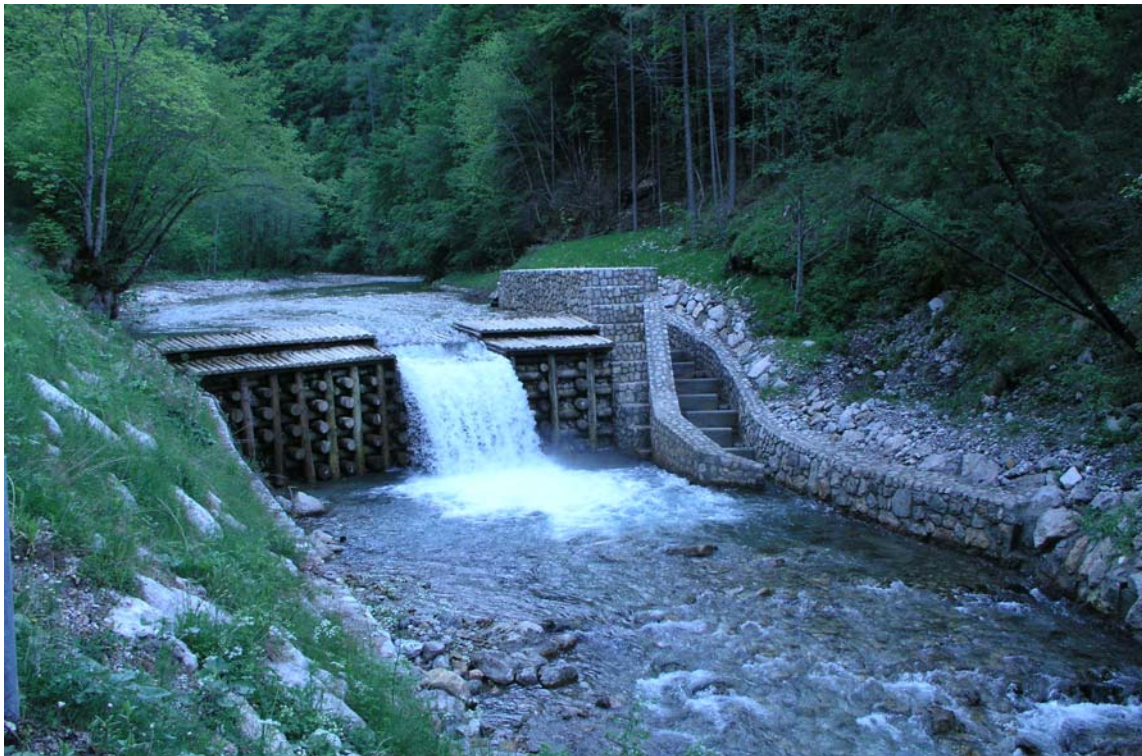
- Reconstruction of old dam
- Construction of the fishway

Figure 2: Dam on the Kokra River after restoration works, situation in 2006.
